Town of Harwich ADA Transition Plan

June 2018

Town Hall

**Town Of Harwich
Town Hall**

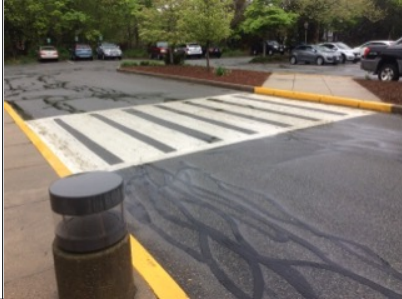
Curb ramp not provided	-	Provide a curb ramp or relocate pedestrian crossing.	2
2	Parking Lot	Ext.		Curb Ramp	34

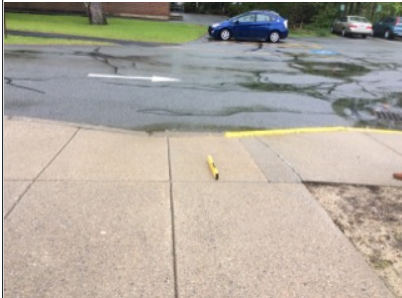
Running slope > 1:12 (8.33%) Detectable warning not provided	10.5% -	Reduce running slope to be no steeper than 1:12 (8.33%). Provide a detectable warning on the curb ramp.	1
3	Towards Main Entrance	Ext.		Curb Ramp	Perpendicular

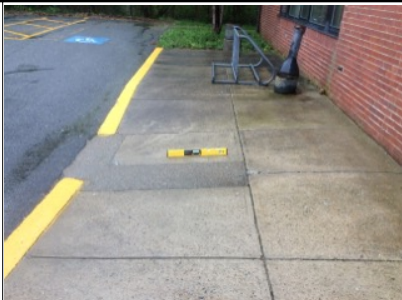
Running slope > 1:12 (8.33%) Detectable warning not provided	9.5% -	Reduce running slope to be no steeper than 1:12 (8.33%). Provide a detectable warning on the curb ramp.	1
4	West Ramp			Curb Ramp	Blended Transition

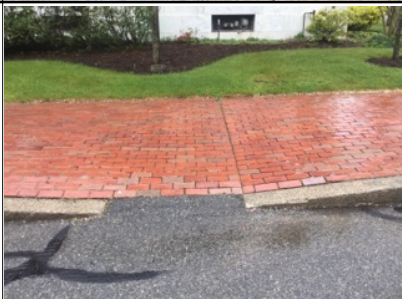
Detectable warning not provided	- -	Provide a detectable warning on the curb ramp.	1
Off-Street Parking Lot or Garage										
5	Parking Lot	Ext.		Off-Street Parking Lot or Garage	Visitor

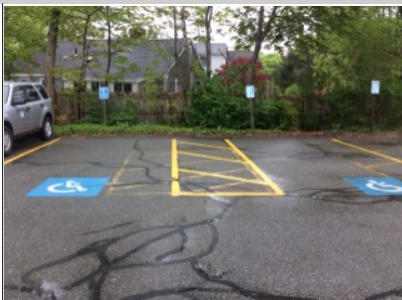
Maintenance of accessible features	-	Ensure features of facilities and equipment that are required to be readily accessible to and usable by persons with disabilities are maintained in operable working conditions.	1

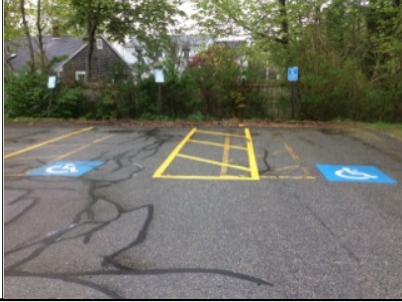
Maintenance of accessible features Sign does not have the designation "Van Accessible"	- -	Ensure features of facilities and equipment that are required to be readily accessible to and usable by persons with disabilities are maintained in operable working conditions. Add the designation "Van Accessible" to the sign located at the van accessible space.	1
Access to Goods and Services										
Interior Access Route										
7	Admin Offices	M		Interior Access Route	N/A

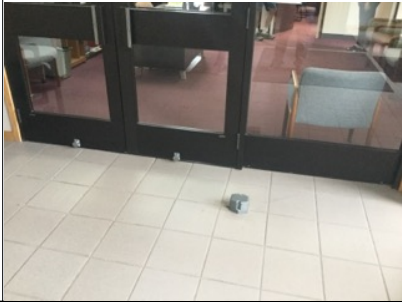
Level changes > 1/4"	4"	Alter the change in level at the door stopper to be 1/4" high max.	1
Doors, Doorways, & Gates										
8	Conference Room - Assessor's Office	1		Doors, Doorways, & Gates	Meeting Room

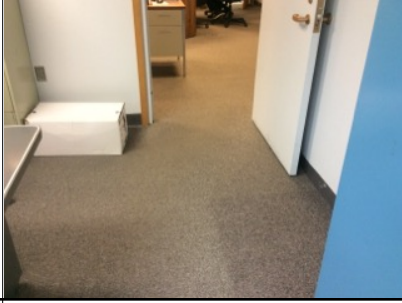
Maneuvering clearance(s) not provided	-	Remove boxes to maintain the clear floor required at the door.	1

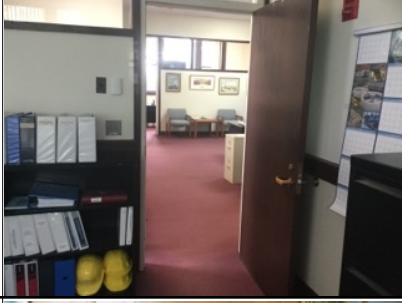
9	Selectmen Conference Room	M		Doors, Doorways, & Gates	Meeting Room

Maneuvering clearance(s) not provided	6"	Relocate the bookshelf to maintain the required 18" maneuvering clearance at the door.	1
10	Library	M		Doors, Doorways, & Gates	Other

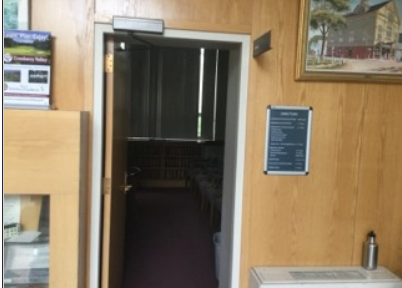
Maneuvering clearance(s) not provided	10"	Ensure the door is kept open when the room is unoccupied during working hours.	1

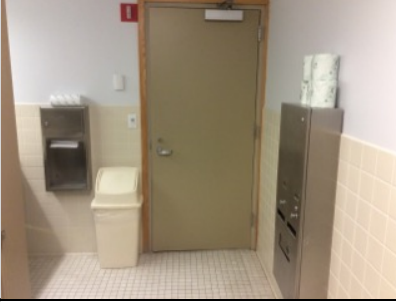
Maneuvering clearance(s) not provided Threshold not beveled Door requires > 5 lbs. of force to open	- - 15 lbs	Relocate trash can to maintain the required 18' maneuvering clearance at the door. Bevel threshold. Adjust closers so doors do not require more than 5 pounds of force to open.	1
12	Men's Toilet Room	1		Doors, Doorways, & Gates	Toilet Room

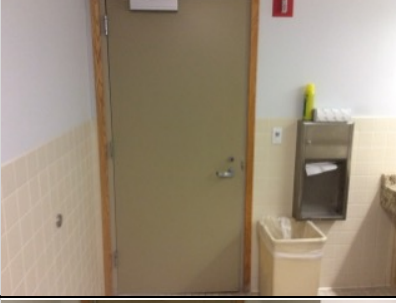
Maneuvering clearance(s) not provided Door requires > 5 lbs. of force to open	- 17 lbs	Relocate trash can to maintain the required 18' maneuvering clearance at the door. Adjust closers so doors do not require more than 5 pounds of force to open.	1
13	Men's Toilet Room	2		Doors, Doorways, & Gates	Toilet Room

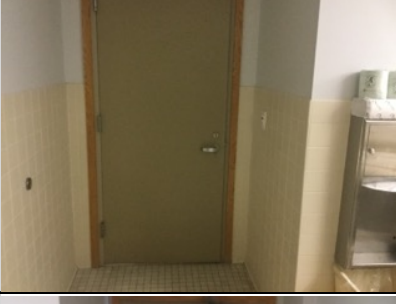
Maneuvering clearance not provided at recess > 8"	8"	Install an automatic door opener.	1

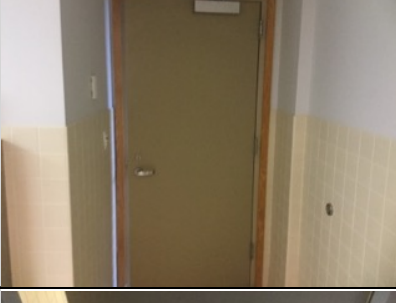
14	Women's Toilet Room	2		Doors, Doorways, & Gates	Toilet Room

Maneuvering clearance not provided at recess > 8"	4"	Install an automatic door opener.	1
15	Men's Toilet Room	2		Doors, Doorways, & Gates	Toilet Room

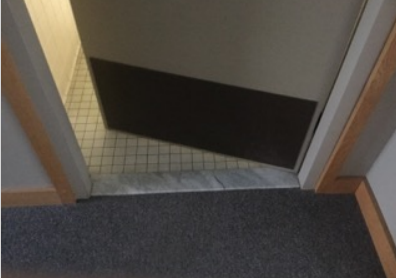
Threshold > 1/2" high	1"	Alter threshold to be 1/2" high max and bevel it.	1

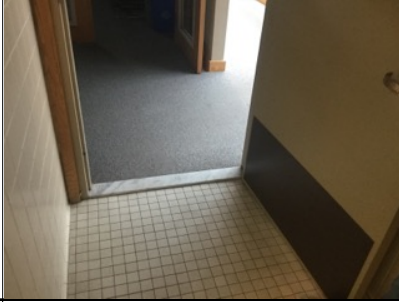
Threshold > 1/2" high	1"	Alter threshold to be 1/2" high max and bevel it.	1
17	Men's Toilet Room	2		Doors, Doorways, & Gates	Toilet Room

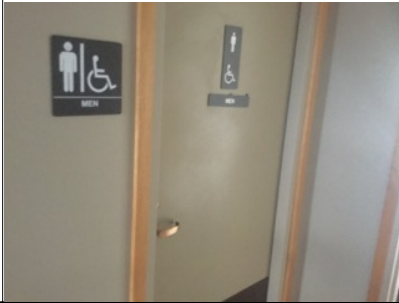
Door requires > 5 lbs. of force to open	15 lbs.	Adjust closers so doors do not require more than 5 pounds of force to open.	1
18	Women's Toilet Room	2		Doors, Doorways, & Gates	Toilet Room

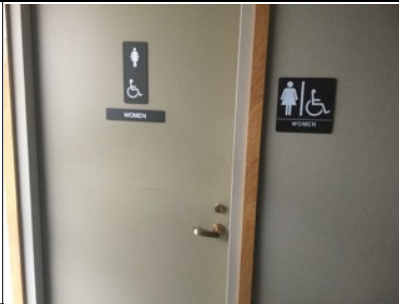
Door requires > 5 lbs. of force to open	19 lbs.	Adjust closers so doors do not require more than 5 pounds of force to open.	1
Stairways										
19	Second Floor to Mezzanine Floor	2		Stairways	Interior

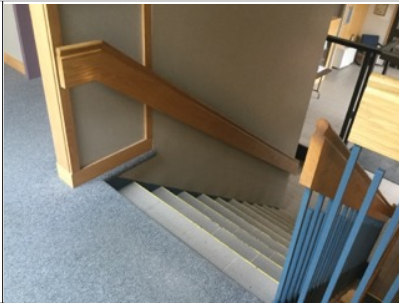
Handrails do not extend 12" from stairs Handrails have non-compliant cross section	- -	Ensure handrails are returned smoothly to posts.	4
Elevator										
20	Elevator on Mezzanine Floor	M		Elevator	Interior

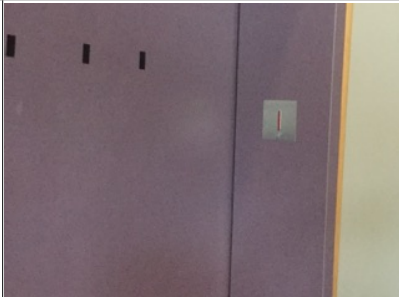
Audible hall signals not provided Tactile stars not provided at main floor on the control panel	- -	Add audible hall signals. Provide a tactile star at the main floor on the control panel within the car.	1

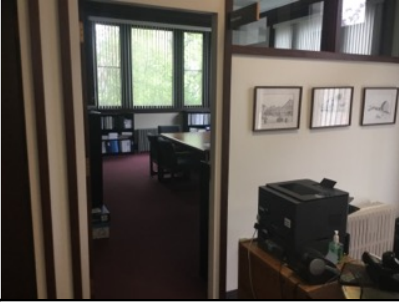
Not provided Maneuvering clearance(s) not provided	-	Locate signage alongside the door on the latch side. Relocate the desk to maintain the required 12" maneuvering clearance at the door.	1
22	Administration Offices	M		Signage	Designation

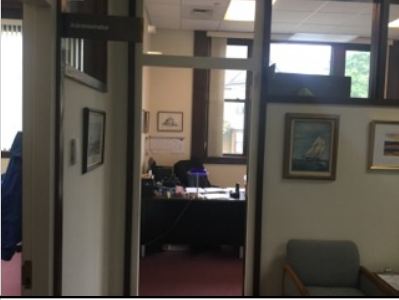
Raised characters not provided Maneuvering clearance(s) not provided	-	Provide text with raised characters duplicated in braille. Relocate the desk to maintain the required 12" maneuvering clearance at the door.	1
23	By Griffin Hearing Room, By Men's Room	2		Signage	Egress

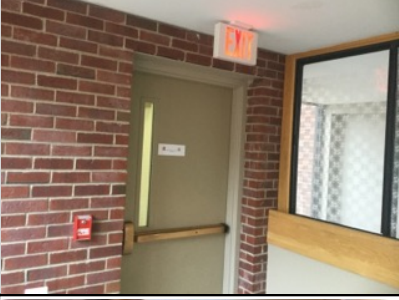
Raised characters not provided Braille not provided	- -	Ensure tactile exit signs are provided at exit doors leading to enclosed stairways and on the interior of the stairway enclosure indicating the floor level. Mount signs between 48"- 60" above finish floor located on the latch side of the door. Cost includes signage at two exit doors on the second floor.	2

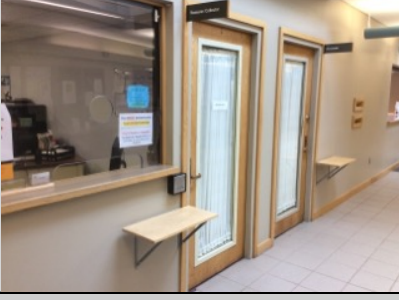
24	Treasurer/Collector; Town Clerk; Assessors; Assessors Maps, Griffin Hearing Room, Library	1, 2		Signage	Designation

Raised characters not provided Braille not provided	- -	Provide text with raised characters duplicated in braille. Mount signs so that the baseline of the lowest tactile character is 48" min. above finish floor and the baseline of the highest tactile character is 60" max. above finish floor. Position braille below the corresponding text. If text is multi-lined place braille below the entire text.	6
Service Counter										
25	Town Clerk	1		Service Counter	N/A

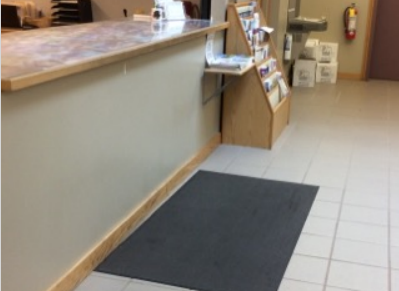
Maintenance of accessible features	43"	Relocate newspapers to ensure that the auxiliary counter required to be readily accessible to and usable by persons with disabilities is maintained in operable working conditions.	1

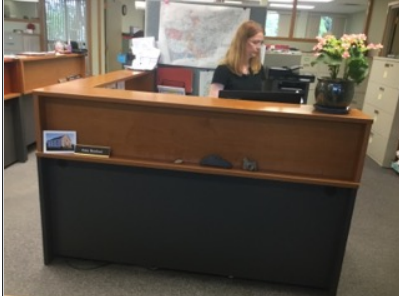
Counter > 36" high	43"	Provide a counter that is 36" max. above the ground or finish floor.	1
27	Lobby	2		Service Counter	N/A

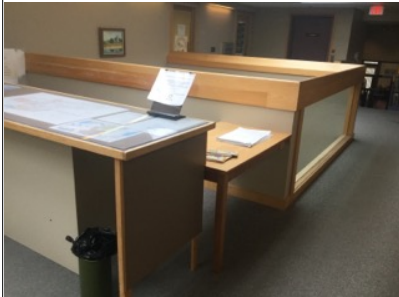
Counter > 36" high	43"	Provide a counter that is 36" max. above the ground or finish floor.	1
Operable Parts										
28	Lobby	1		Operable Parts	Other

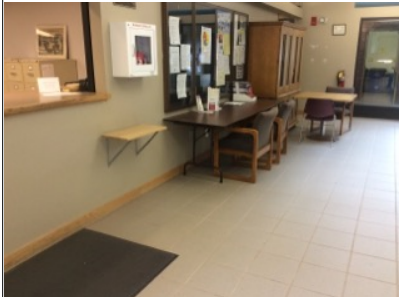
Clear floor space is not provided Reach < 15" or > 48"(forward/side approach)	- 57.5"	Relocate AED to provide a 30" min. by 48" min. clear floor space position for a forward or parallel approach. Mount AED so that controls are 48" above finish floor.	1
29	Health, Historic, And Conservation	2		Operable Parts	Other

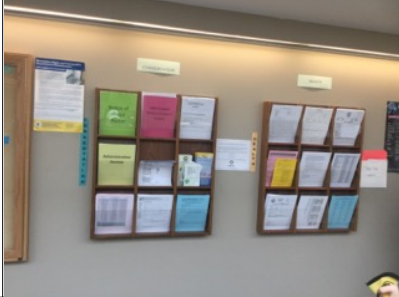
Side reach > 48"	68"	Relocate shelves so that all papers are 48" max. above finish floor.	1
Dining or Work Surfaces										
30	Conference Room - Assessor's Office	1		Dining or Work Surfaces	Work Surface

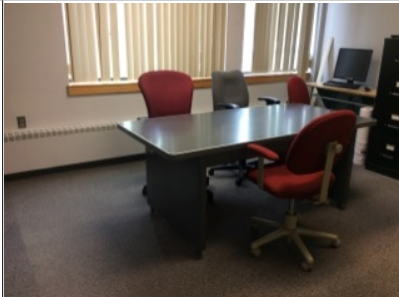
Knee or toe clearance not provided	-	Provide a work surface with 27" min. knee and toe clearance.	1

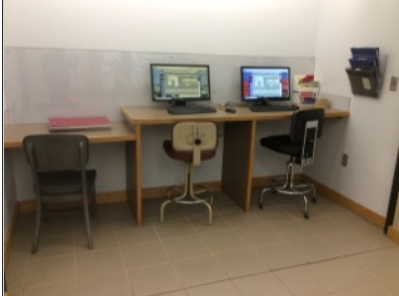
Top of dining/work surface < 28" or > 34"	36"	Provide at least one work surface with top between 28"- 34" above the floor and 27" clear height underneath.	1	
32	Library	M		Dining or Work Surfaces	Work Surface

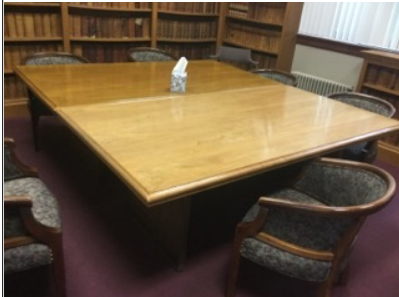
Top of work surface < 28" or > 34"	26"	Provide one work surface with tops between 28"- 34" above the floor and 27" clear height underneath.	1	
33	Selectmens Conference Room	M		Dining or Work Surfaces	Work Surface

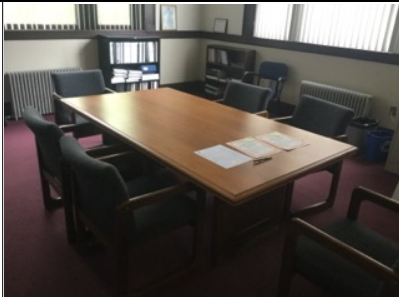
Top of work surface < 28" or > 34"	26"	Provide one work surface with tops between 28"- 34" above the floor and 27" clear height underneath.	1	
Assembly Area											
34	Griffin Hearing Room	2		Assembly Area	N/A

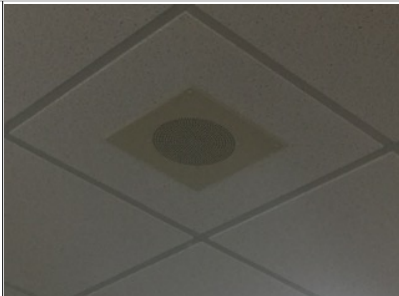
Assistive listening devices not provided	-	If audible communication is integral to the use of the space, provide an assistive listening system. Cost provided for room capacity of 50 people.	1

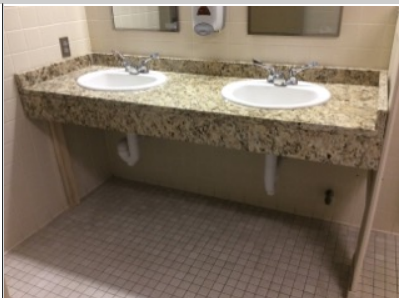
Mirror above lavatory w/reflective surface > 40"	42"	Lower mirror so that the bottom surface is at 40" max. above finish floor.	1

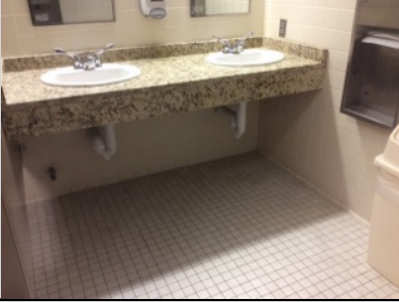
Mirror above lavatory w/reflective surface > 40"	42.25"	Lower mirror so that the bottom surface is at 40" max. above finish floor.	1
Toilet Compartment										
37	Women's Toilet Room	2		Toilet Compartment	Accessible Compartment

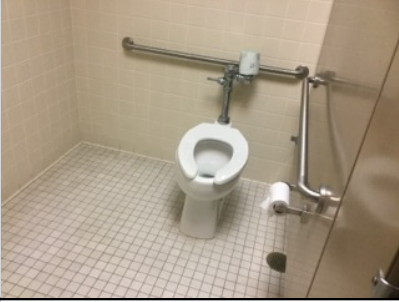
Door has malfunctioning self-closing hinge Side or rear grab bar < 33" or >36" high	- 32"	Repair hinge. Locate grab bars between 33"- 36" above the finish floor. The rear grab bar should be located 6" from the side wall - it is technically not compliant but usable.	1
38	Women's Toilet Room	1		Toilet Compartment	Accessible Compartment

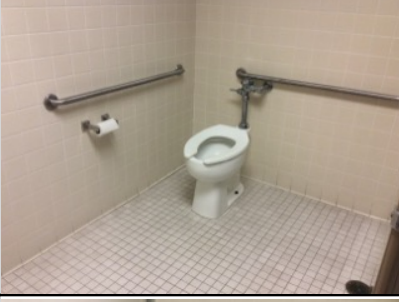
Door has malfunctioning self-closing hinge Rear grab bar > 6" from the side wall Flush control not on open side	- - -	Repair hinge. Relocate rear grab bar 6" from the side wall. Provide the flush control on the open side of the toilet (transfer side).	1

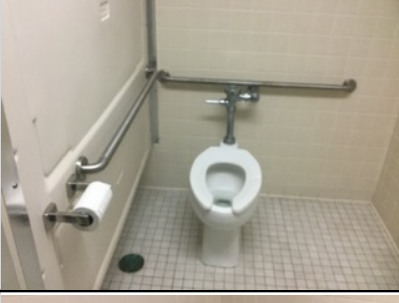
39	Men's Toilet Room	2		Toilet Compartment

Side or rear grab bar < 33" or >36" high Flush control not on open side Rear grab bar < 42" long	32" 35" -	Locate grab bars between 33"- 36" above the finish floor. Provide a rear wall grab bar that is 42" long min. and extends from the toilet 12" min. on one side and 24" min. on the other side (open side). Provide the flush control on the open side of the toilet (transfer side). The rear grab bar should be located 6" from the side wall - it is technically not compliant but usable.	1
40	Men's Toilet Room	1		Toilet Compartment	Accessible Compartment

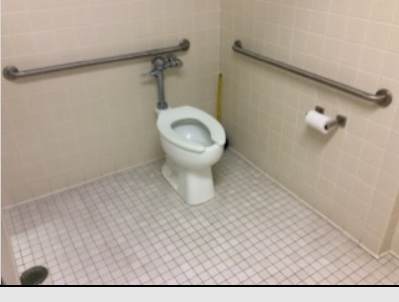
Rear grab bar > 6" from the side wall	11.5"	Relocate rear grab bar 6" from the side wall.	1
Additional Access

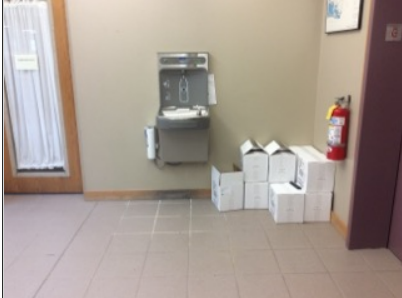
Clear floor space not provided	-	Remove boxes to ensure a 30" by 48" clear floor space is maintained at the accessible drinking fountain.	1
