Bank Street Beach Harwich, MA

Town of Harwich ADA Transition Plan

June 2018

Bank Street Beach, Harwich, MA

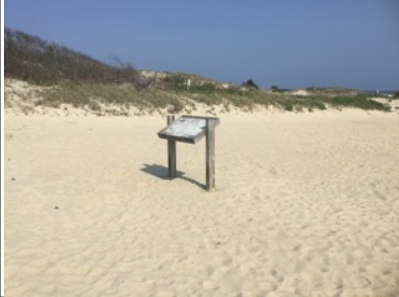
Accessible route not provided	45'	Ensure an accessible route is provided to the wayside. Relocate to an accessible location.	1
Off-Street Parking Lot or Garage										
2	Parking Lot	Ext.		Off-Street Parking Lot or Garage	Visitor

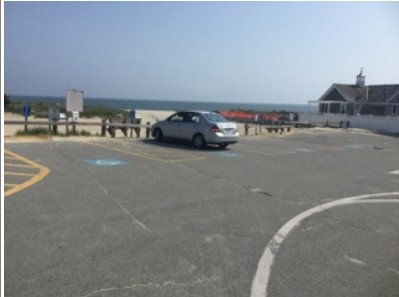
Total # of parking Total # of designated accessible parking spaces Total # of designated van accessible spaces Slope at space and access aisle > 1:50 (2.00%) (MAAB) Access aisle not provided Sign does not have the designation "Van Accessible" Sign < 60" above finished grade	60 2 3 5.9% - - 36"	Reduce slope to be no steeper than 1:50 (2.00%) in all directions at the three access aisles. Provide a marked access aisle that is at least 60" wide at both car accessible spaces. Add the designation "Van Accessible" to the signs located at the van accessible spaces. Locate sign with the bottom of the sign 60" above the ground.	1

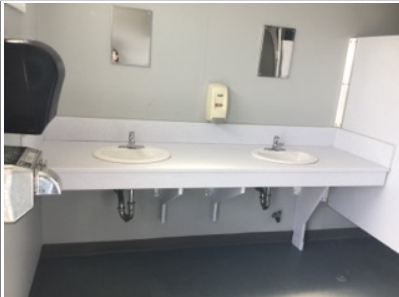
Access to Goods and Services										
Interior Access Route										
3	Men's Toilet Room	Ext.		Interior Access Route	Interior

Obstructed by protruding objects	10"	Relocate hand dryer so it does not protrude into the circulation path./Provide a cane detectable barrier 27" max. above the finished floor.	1
4	Women's Toilet Room	1		Interior Access Route	Interior

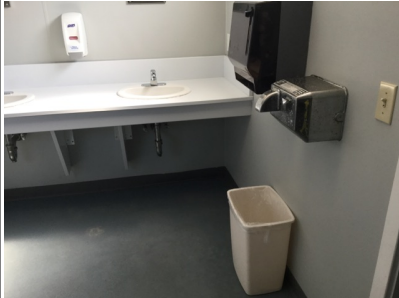
Obstructed by protruding objects	7"	Relocate object./Provide a cane detectable barrier.	1

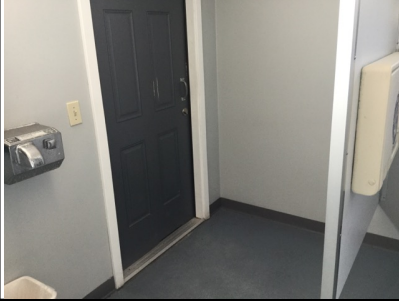
ID	Location	Floor	Room	Element	Type	Photo	Issues	Current Measure	Recommendations	Quantity
Doors, Doorways, & Gates										
5	Women's Toilet Room	1		Doors, Doorways, & Gates	Toilet Room

Threshold not beveled	-	Bevel threshold.	1
6	Men's Toilet Room	Ext.		Doors, Doorways, & Gates	Toilet Room

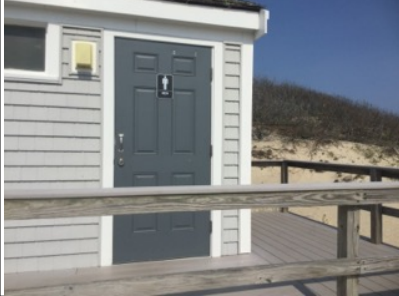
Door requires > 5 lbs of force to open	18lbs	Adjust closers so doors do not require more than 5 pounds of force to open.	1
Ramps										
7	Women's Toilet Room	Ext.		Ramps	Exterior

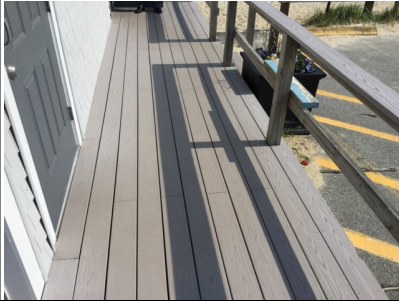
Edge protection not provided	-	Add railings located 2" above the ramp so as to prevent people from slipping off the ramp.	1
8	Towards Toilet Rooms	Ext.		Ramps	Exterior

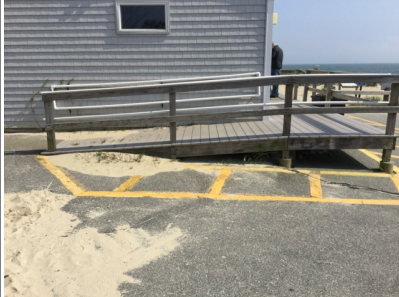
Handrails do not extend 12" past top & bottom Handrails have non-compliant cross section Edge protection not provided	- - -	Alter handrails to extend horizontally above the landing for 12" min. beyond the top and bottom of ramp runs. Provide handrails with a 1 1/4" - 2" circular cross section. Add railings located 2" above the ramp so as to prevent people from slipping off the ramp.	1

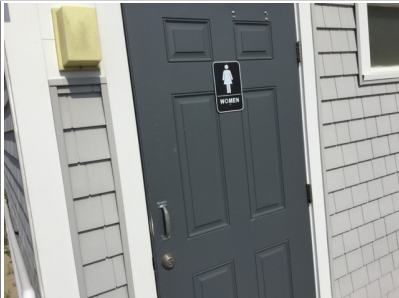
Signage										
9	Women's Toilet Room	1		Signage	Designation

Raised characters < 48" or > 60 " above ground Sign not located on the latch side of the door	60.5" -	Mount signs so that the baseline of the lowest tactile character is 48" min. above finish floor and the baseline of the highest tactile character is 60" max. above finish floor. Locate sign at permanent rooms alongside the door on the latch side.	1

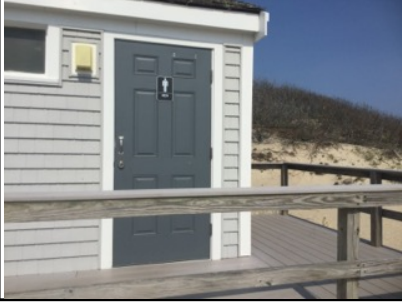
ID	Location	Floor	Room	Element	Type	Photo	Issues	Current Measure	Recommendations	Quantity
10	Men's Toilet Room	Ext.		Signage	Designation

Sign not located on the latch side of the door	-	Locate sign at permanent rooms alongside the door on the latch side with tactile characters located 48" min. and 60" max. AFF measured to the baseline of the highest tactile character.	1
Benches										
11	Route to Beach	Ext.		Benches	N/A

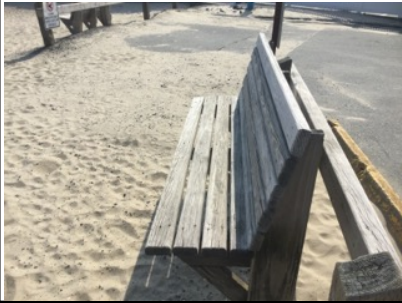
No accessible route to 20% of benches 20% of benches have clear space < 36" x 48"	- -	Provide an accessible route to at least one bench in this area and ensure that the bench has a clear floor space of 36" wide min. by 48" deep min. (Cost is for a level asphalt patch alongside bench.)	1
Bike Racks										
12	Parking Lot	Ext.		Bike Racks	N/A

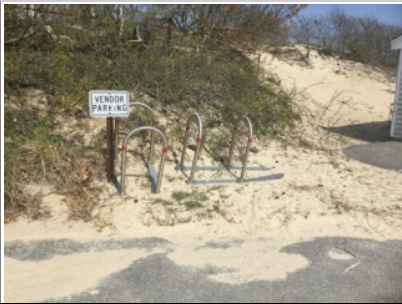
Not connected to an accessible route	-	Ensure bike racks are connected to an accessible route.	1
Trash / Recycling

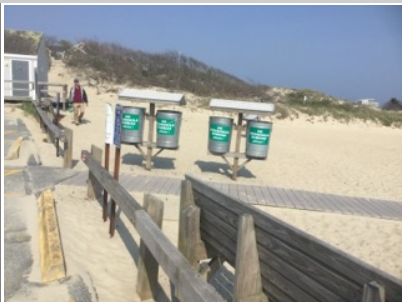
13	Route to Beach	Ext.		Trash / Recycling	N/A

Trash container not connected to an accessible route	-	Ensure trash container is located on an accessible route. Relocate to parking lot side of fence.	1
Toilet & Bathing Rooms

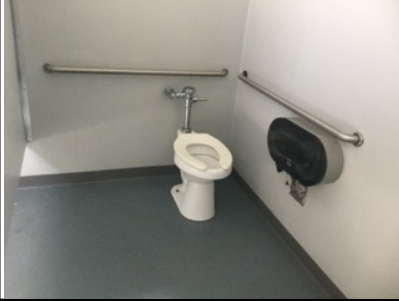
ID	Location	Floor	Room	Element	Type	Photo	Issues	Current Measure	Recommendations	Quantity
Overall Access										
14	Men's Toilet Room	Ext.		Overall Access	Toilet Room

Audible and visible alarms not provided	-	When fire system is updated, ensure that a visible and audible fire alarm is installed.	1
Lavatory										
15	Men's Toilet Room	Ext.		Lavatory	N/A

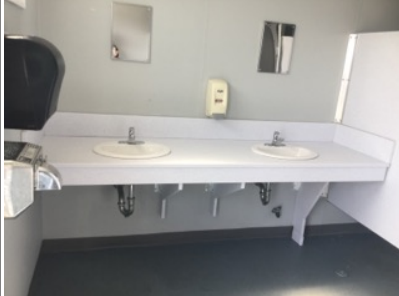
Exposed plumbing underneath Mirror above lavatory w/reflective surface > 40"	- 56"	Insulate or otherwise configure pipes to prevent contact, for at least one lavatory. Lower mirror so that the bottom surface is at 40" max. above finish floor.	1
16	Women's Toilet Room	1		Lavatory	N/A

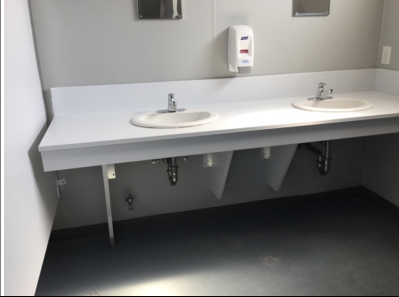
Exposed plumbing underneath Mirror above lavatory w/reflective surface > 40"	- 55.5"	Insulate or otherwise configure pipes to prevent contact, for at least one lavatory. Lower mirror so that the bottom surface is at 40" max. above finish floor.	1
Toilet Compartment

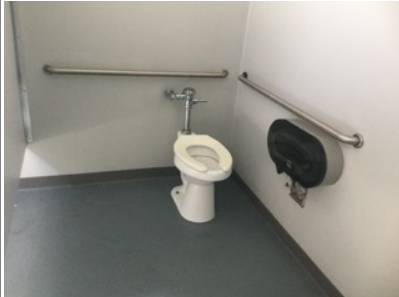
17	Men's Toilet Room	Ext.		Toilet Compartment	Accessible Compartment

Flush control not on open side	- -	Provide the flush control on the open side of the toilet (transfer side).	1
18	Women's Toilet Room	1		Toilet Compartment	Accessible Compartment

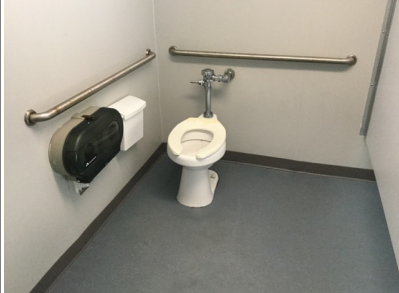
Flush control not on open side	-	Provide the flush control on the open side of the toilet (transfer side).	1

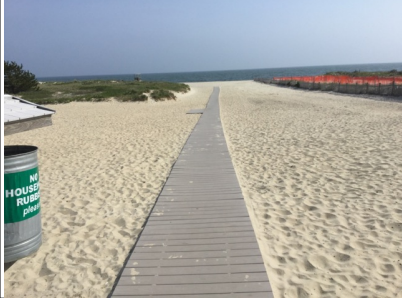
ID	Location	Floor	Room	Element	Type	Photo	Issues	Current Measure	Recommendations	Quantity
Universal Design										
Seating Areas										
19	Route to the Beach	Ext.		Seating Areas	N/A

Recommend providing seating areas near the high tide level area at the beach.	1
Stairs										
20	Near Toilet Rooms	Ext.		Stairs	N/A

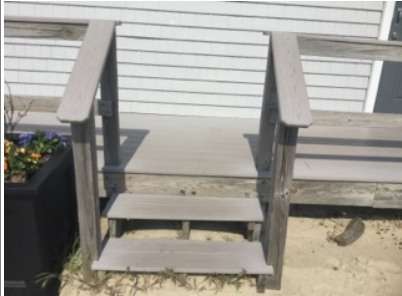
Stairs have open risers Handrails have non-compliant cross section	-	Fill in open stair risers. Recommend providing handrails with a 1 1/4" - 2" circular cross section.	1
