Cultural Center Harwich, MA

Town of Harwich ADA Transition Plan

June 2018

Cultural Center, Harwich, MA

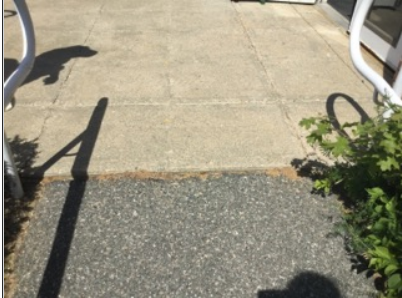
**Town of Harwich
Harwich Cultural Center**

Level changes > 1/4"	1"	Alter change in level to be 1/4" high max.	1
Curb Ramp										
2	From Accessible Parking Towards Accessible Entrance	Ext.		Curb Ramp	Parallel

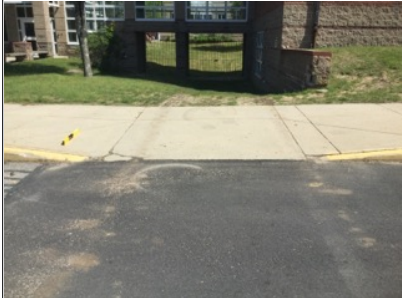
Landing not provided at top of curb ramp Detectable warning not provided	- -	Provide landing at top of curb ramp or reconfigure ramp. Provide a detectable warning on the curb ramp.	1
Off-Street Parking Lot or Garage										
3	Parking Lot 2 by Ramp	Ext.		Off-Street Parking Lot or Garage	Visitor

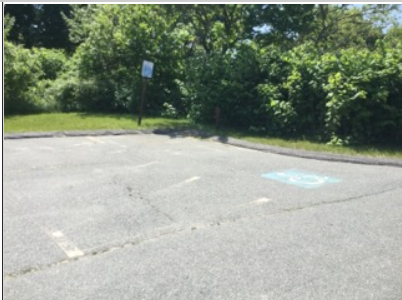
Total # of parking Total # of designated accessible parking spaces Total # of designated van accessible spaces Sign < 60" above finished grade	19 1 0 55"	Repaint space and aisle to provide a van accessible space. Locate sign with the bottom of the sign 60" above the ground and add the designation "Van Accessible".	1

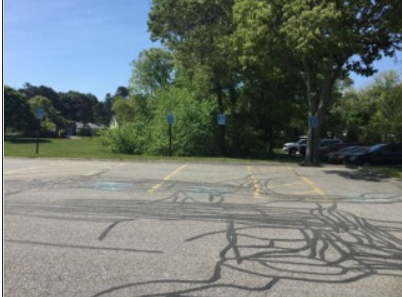
4	Parking Lot at Front Entrance	Ext.		Off-Street Parking Lot or Garage	Visitor

Total # of parking Total # of designated accessible parking spaces Total # of designated van accessible spaces Vehicle space < 96" wide at car space Access aisle < 60" wide at car space Access aisle < 96" wide at van space Sign does not have the designation "Van Accessible"	39 4 0 92" 58" 91"	Ensure that accessible car spaces are at least 96" wide with an access aisle at least 60" wide. Provide a marked access aisle that is at least 96" wide at the van space. Add the designation "Van Accessible" to the sign located at the van accessible space.	1

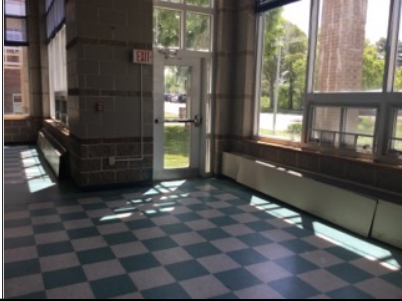
ID	Location	Floor	Room	Element	Type	Photo	Issues	Current Measure	Recommendations	Quantity
Emergency Exit										
5	Cafeteria	1		Emergency Exit	N/A

Emergency exit not on an accessible route		Provide a directional sign indicating the location of the nearest emergency exit.	1
Access to Goods and Services										
Interior Access Route										
6	Women's Shower	1		Interior Access Route	N/A

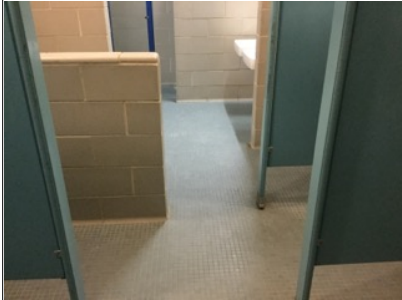
Route < 36" wide	24"	Ensure that a clear width of 36" min. is maintained at the accessible route.	1
7	Men's Locker Room to Men's Toilet Room	1		Interior Access Route	N/A

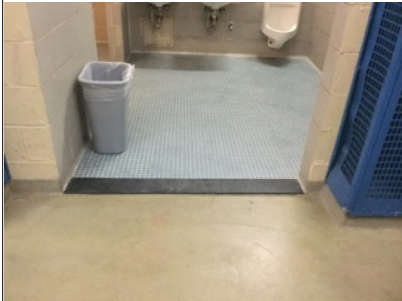
Level changes > 1/4"	1.5"	Alter change in level to be 1/4" high max.	1
8	Women's Locker Room to Women's Toilet Room	1		Interior Access Route	N/A

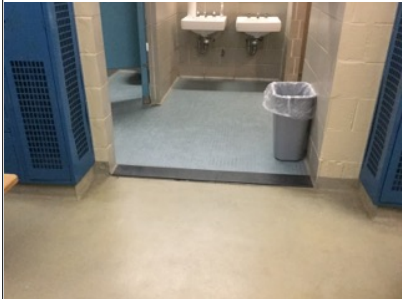
Level changes > 1/4"	1.5"	Alter change in level to be 1/4" high max.	1

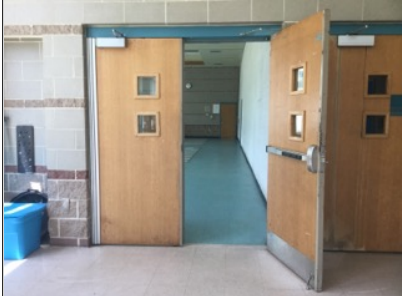
ID	Location	Floor	Room	Element	Type	Photo	Issues	Current Measure	Recommendations	Quantity
Doors, Doorways, & Gates										
9	Cafeteria & Kitchen	1		Doors, Doorways, & Gates	Assembly Space

Door requires > 5 lbs. of force to open	16 lbs.	Adjust closers so doors do not require more than 5 pounds of force to open.	1
10	Exit Door to Auditorium	1		Doors, Doorways, & Gates	Assembly Space

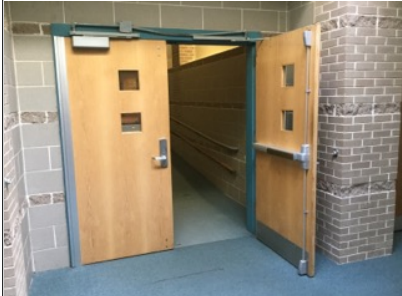
Door requires > 5 lbs. of force to open	21 lbs	Adjust closers so doors do not require more than 5 pounds of force to open.	1
11	Girl's Toilet Room	2		Doors, Doorways, & Gates	Toilet Room

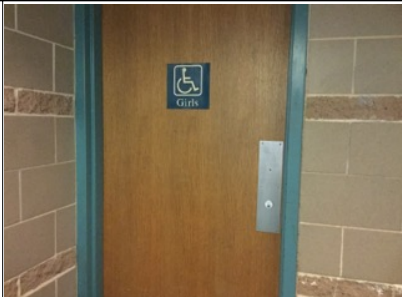
Door requires > 5 lbs. of force to open	11 lbs	Adjust closers so doors do not require more than 5 pounds of force to open.	1
12	Girl's Toilet Room	1		Doors, Doorways, & Gates	Toilet Room

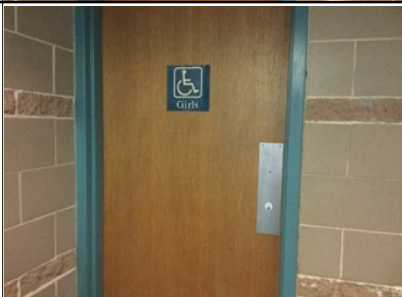
Door requires > 5 lbs. of force to open	11 lbs.	Adjust closers so doors do not require more than 5 pounds of force to open.	1
13	Single-User Toilet Room	1		Doors, Doorways, & Gates	Toilet Room

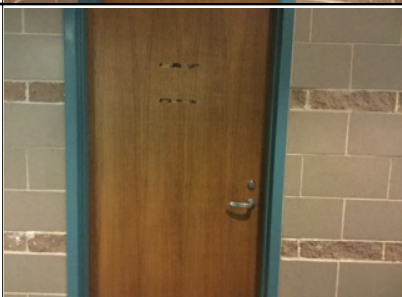
Door requires > 5 lbs. of force to open	16 lbs	Adjust closers so doors do not require more than 5 pounds of force to open.	2

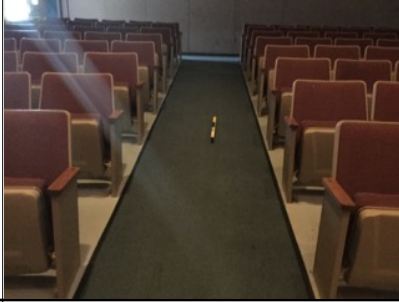
ID	Location	Floor	Room	Element	Type	Photo	Issues	Current Measure	Recommendations	Quantity
Ramps										
14	Auditorium	1		Ramps	Interior

Running slope >1:12 (8.33%)	13.2%	Providing a ramp with a compliant running slope may be technically infeasible.	1
15	Ramp near First Floor Toilet Rooms	1		Ramps	Interior

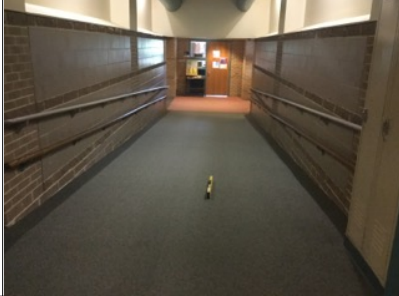
Running slope >1:12 (8.33%) Handrails < 34" or > 38" above ramp surface. Handrails do not extend 12" past top & bottom	8.7% 31" -	Providing a ramp with a compliant running slope may be technically infeasible. Alter so the handrails are 34"- 38" high above the floor and extend horizontally above the landing for 12" min. beyond the top and bottom of ramp runs.	4
16	By Rooms 204 and 205	2		Ramps	Interior

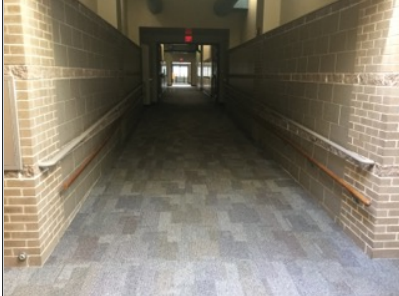
Handrails < 34" or > 38" above ramp surface.	31"	Alter so the handrails are 34"- 38" high above the floor.	1
17	Near Room 110	1		Ramps	Interior

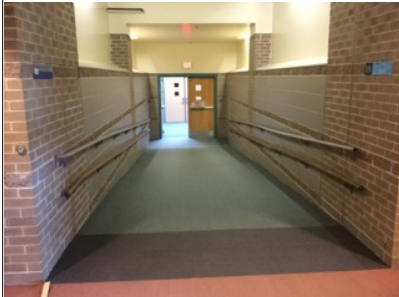
Handrails < 34" or > 38" above ramp surface. Handrails do not extend 12" past top & bottom	32" -	Alter so the handrails are 34"- 38" high above the floor and extend horizontally above the landing for 12" min. beyond the top and bottom of ramp runs.	2

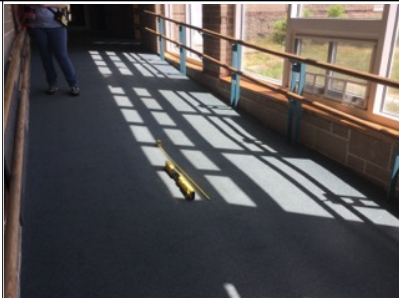
18	To Auditorium	1		Ramps	Interior

Handrails < 34" or > 38" above ramp surface. Landing < 60" min. deep	32" 42"	Alter so the handrails are 34"- 38" high above the floor. Alter so the landing is 60" long min. Providing a ramp with a compliant running slope may be technically infeasible.	1

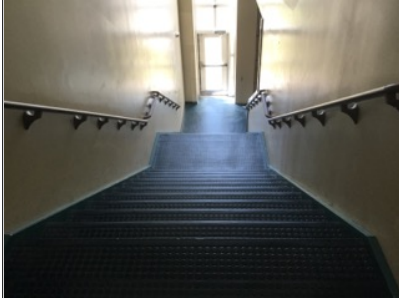
ID	Location	Floor	Room	Element	Type	Photo	Issues	Current Measure	Recommendations	Quantity
Stairways										
19	Stairway Near Music Room	2		Stairways	Interior

Handrail height < 34" or > 38"	32"	Alter so the handrails are 34"- 38" high above the floor.	1
20	Entry to Second Floor	2		Stairways	Interior

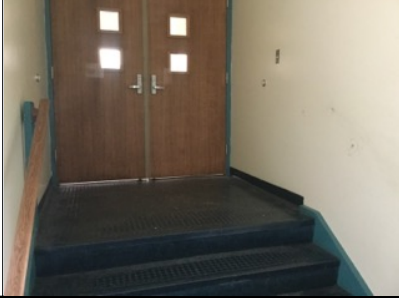
Handrail height < 34" or > 38" Handrail not provided on both sides Handrails do not extend 12" from stairs	31" - -	Alter so the handrails are 34"- 38" high above the floor. Provide handrail on one side. Top and bottom: Ensure handrails extend horizontally above the landing for 12" min. beginning above the first riser nosing.	1
21	Side Stairs to Front Half of Building	1		Stairways	Interior

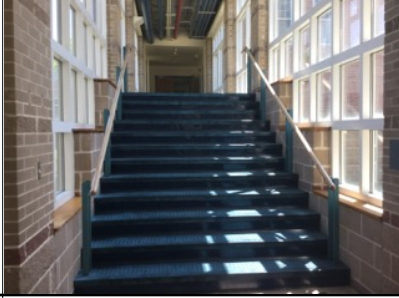
Handrail height < 34" or > 38" Handrails do not extend 12" from stairs	33" -	Alter so the handrails are 34"- 38" high above the floor. Bottom: Ensure handrails extend horizontally above the landing for 12" min. beginning above the first riser nosing.	2

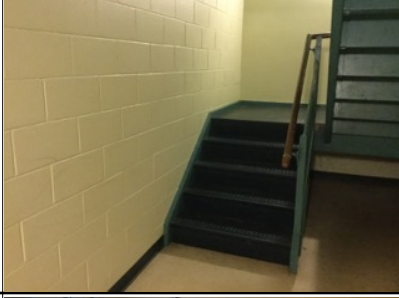
22	Basement	B		Stairways	Interior

Handrail not provided on both sides	-	Provide handrail on one side.	1
23	Near Main Entrance	1		Stairways	Interior

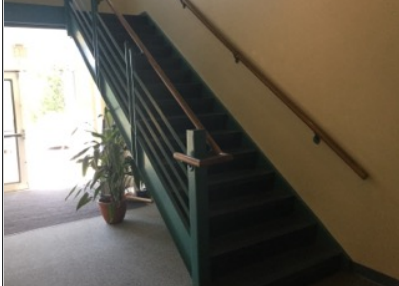
Handrails do not extend 12" from stairs	-	Ensure handrails extend horizontally above the landing for 12" min. beginning above the first riser nosing.	1

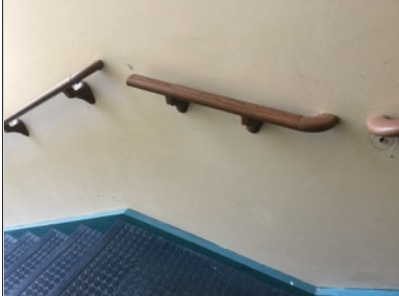
ID	Location	Floor	Room	Element	Type	Photo	Issues	Current Measure	Recommendations	Quantity
24	Stairway Near Auditorium	2		Stairways	Interior

Handrails not continuous where required	-	Provide continuous handrails.	2
25	To Renter Studio	1	Basement	Stairways	Interior

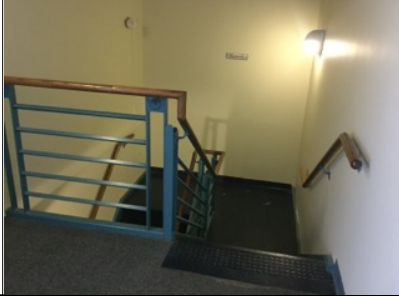
Handrails not continuous where required	-	Provide continuous handrails.	1
Elevator										
26	Elevator	2		Elevator	Interior

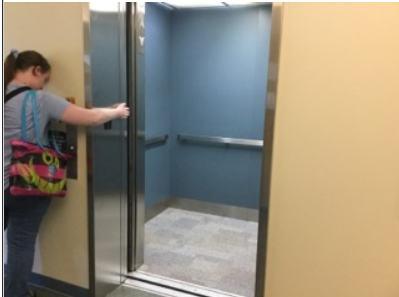
Visible and audible hall signals not provided Tactile stars not provided at main entry level	-	Add visible and audible hall signals. Provide a tactile star on both sides of jambs at main floor. At other floors, provide appropriate number. Provide a tactile star at the main floor on the control panel within the car.	1
Signage										
27	Men's Locker Room, Women's Locker Room	1		Signage	Designation

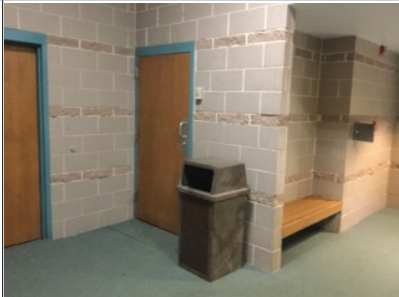
Not provided	-	Locate signage alongside the door on the latch side.	2
28	Single-User Toilet Rooms	2		Signage	Designation

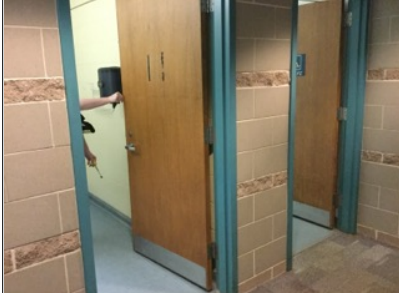
Not provided	-	Locate signage alongside the door on the latch side.	2

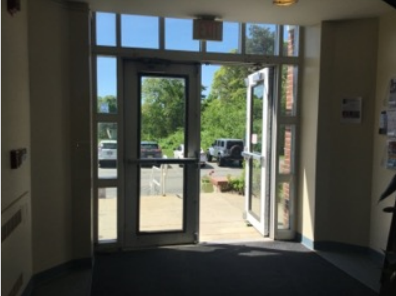
ID	Location	Floor	Room	Element	Type	Photo	Issues	Current Measure	Recommendations	Quantity
29	Front Lobby	1		Signage	Egress

Raised characters not provided Braille not provided	- -	Provide text with raised characters duplicated in braille at all emergency egress doors.	17
30	Girl's Toilet Room	1, 2		Signage	Designation

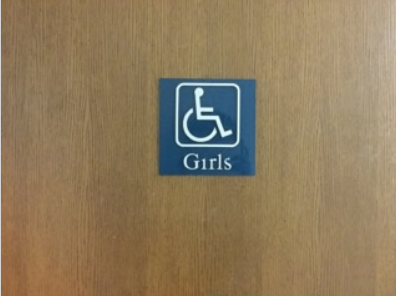
Raised characters not provided Braille not provided Sign not located on the latch side of the door	- - -	Provide text with raised characters duplicated in braille. Locate sign alongside the door on the latch side.	1
31	Men's Toilet Room	1		Signage	Designation

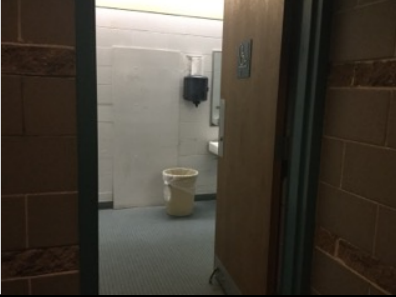
Braille not provided Sign not located on the latch side of the door	- -	Provide braille. Locate sign alongside the door on the latch side.	1
32	Music Room Men's and Women's Toilet Rooms	1		Signage	Designation

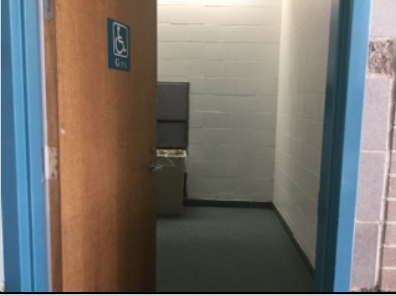
Braille not provided Sign not located on the latch side of the door	- -	Provide braille. Locate sign alongside the door on the latch side.	2

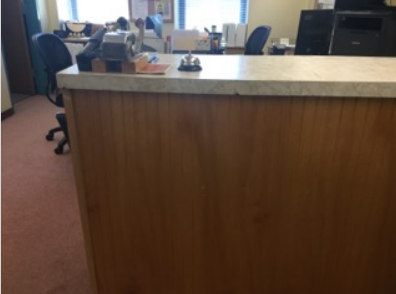
Service Counter										
33	Harbormaster Department	1		Service Counter	N/A

Counter > 36" high	42"	Provide a counter that is 36" max. above the ground or finish floor.	1

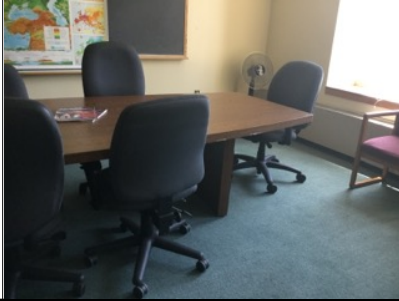
ID	Location	Floor	Room	Element	Type	Photo	Issues	Current Measure	Recommendations	Quantity
Dining or Work Surfaces										
34	Program Manager Office	1		Dining or Work Surfaces	Work Surface

Knee or toe clearance not provided	26"	Provide at least 1 work surface with 27" min. knee and toe clearance.	1
Assembly Area										
35	Auditorium	1		Assembly Area	N/A

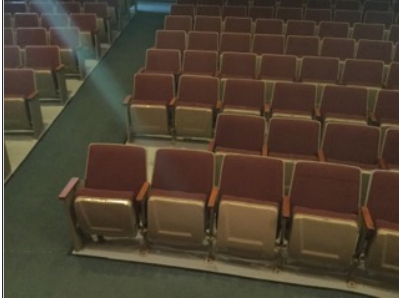
Number of seats Number of designated wheelchair spaces Minimum # wheelchair spaces not provided Wheelchair spaces not on accessible route Designated aisle seats < 1% (MAAB) Assistive listening devices not provided	236 1 - - -	Provide five (5) wheelchair spaces on a level seating area with signs. 3 aisle seats must be identified by a sign or marker and have folding or retractable armrests. If audible communication is integral to the use of the space, provide an assistive listening system. (Cost calculated for a capacity of 250.)	1

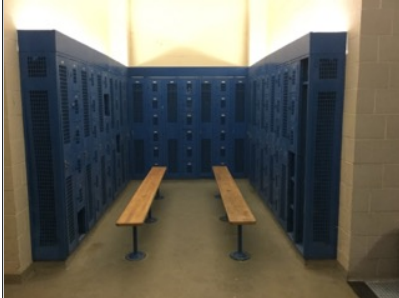
Locker Room										
36	Men's Locker Room, Women's Locker Room	1		Locker Room	Men's

Total # of locker Total # of accessible locker 5% of lockers are not accessible Clear floor space not provided Non-compliant hardware	160 0 - -	Ensure 8 lockers at the men's locker room and the women's locker room are accessible. Provide a 30" min. by 48" min. clear floor space at accessible lockers. Provide hardware that can be operable with one hand and not require tight grasping, pinching, or twisting of the wrist.	2
37	Women's Locker Room	1		Locker Room	Women's

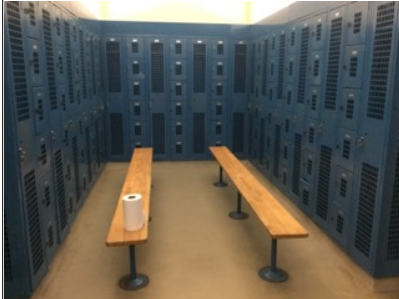
Back support not provided at bench	-	Provide at least one bench with back support or that is affixed to a wall with room on the side to transfer.	1
38	Men's Locker Room	1		Locker Room	Men's

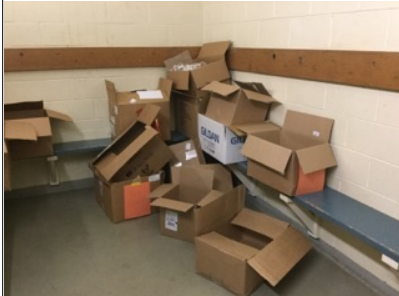
Bench is not 17"-19" high Bench < 20" or > 24" deep	20" -	Install a bench with the top of the seat between 17"- 19" above finish floor and 20"- 24" deep max.	1

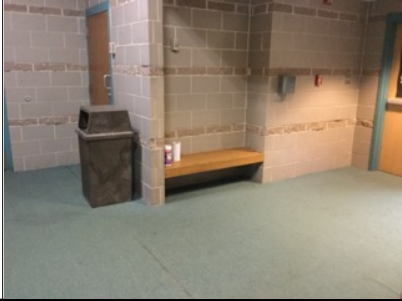
ID	Location	Floor	Room	Element	Type	Photo	Issues	Current Measure	Recommendations	Quantity
Benches										
39	Near Toilet Rooms	1		Benches	N/A

20% of benches have clear space < 36" x 48"	-	Relocate bench to ensure that 20% of benches have a clear floor space of 36" wide min. by 48" deep min.	1
Kitchens and Kitchenettes										
40	Cafeteria	1		Kitchens and Kitchenettes	Other

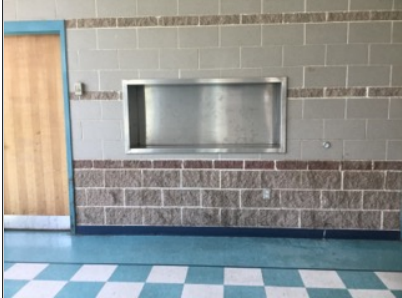
Countertop > 34" height	37"	Lower countertop to provide a work surface no higher than 34" positioned for a forward approach.	1
Toilet & Bathing Rooms										
Overall Access										
41	Men's Toilet Room, Women's Toilet Room, Music Room Men's and Women's Toilet Rooms, Boys Toilet	1		Overall Access	Toilet Room	 	Audible and visible alarms not provided		When fire system is updated, ensure that a visible and audible fire alarm is installed.	5
Lavatory										
42	Men's Toilet Room	1		Lavatory	N/A

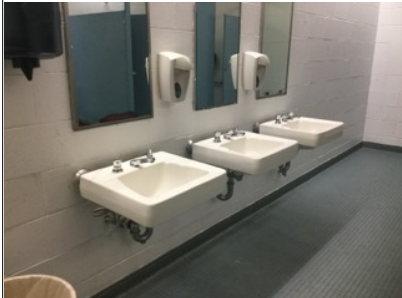
Toe or knee clearances not provided Dispensers not within reach range	25" 48"	Provide at least one lavatory with knee and toe clearance positioned for a forward approach. Relocate dispenser to 42" max. above the floor.	1

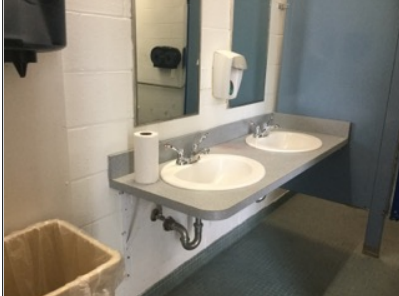
ID	Location	Floor	Room	Element	Type	Photo	Issues	Current Measure	Recommendations	Quantity
43	Music Room Men's Toilet Room	1		Lavatory	N/A

Plumbing underneath is exposed		Insulate or otherwise configure pipes to prevent contact, for at least one lavatory.	1
44	Music Room Women's Toilet Room	1		Lavatory	N/A

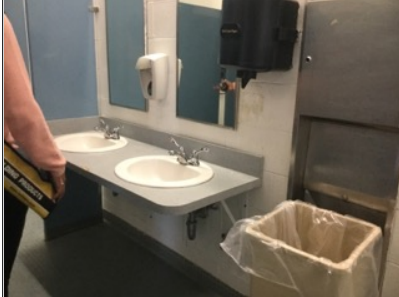
Plumbing underneath is exposed	-	Insulate or otherwise configure pipes to prevent contact, for at least one lavatory.	1
45	Boy's Toilet Room	2		Lavatory	N/A

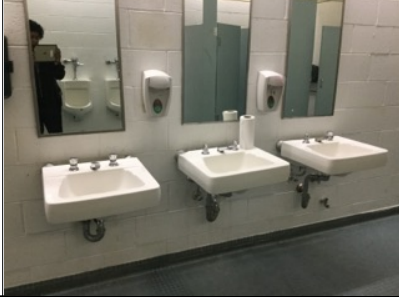
Plumbing underneath is exposed Dispensers not within reach range	- 49"	Insulate or otherwise configure pipes to prevent contact, for at least one lavatory. Relocate dispenser to 42" max. above the floor.	1
46	Men's Toilet Room	1		Lavatory	N/A

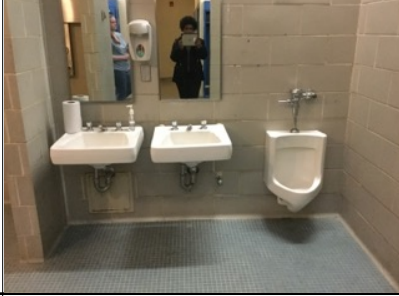
Plumbing underneath is exposed Dispensers not within reach range	- 57"	Insulate or otherwise configure pipes to prevent contact, for at least one lavatory. Relocate dispenser to 42" max. above the floor.	1

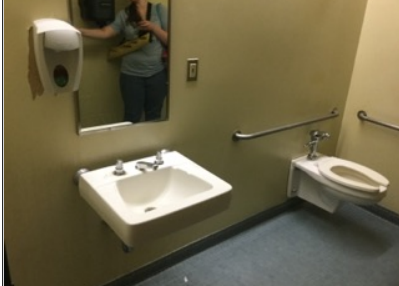
47	Single-User Toilet Room	2		Lavatory	N/A

Plumbing underneath is exposed Dispensers not within reach range	- 54"	Insulate or otherwise configure pipes to prevent contact at lavatory. Relocate dispenser to 42" max. above the floor.	1

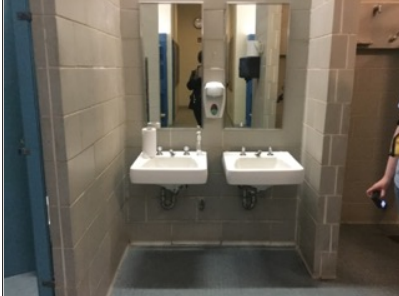
ID	Location	Floor	Room	Element	Type	Photo	Issues	Current Measure	Recommendations	Quantity
48	Women's Toilet Room	1		Lavatory	N/A

Plumbing underneath is exposed Dispensers not within reach range	- 50"	Insulate or otherwise configure pipes to prevent contact, for at least one lavatory. Relocate dispenser to 42" max. above the floor.	1
49	Girl's Toilet Room	2		Lavatory	N/A

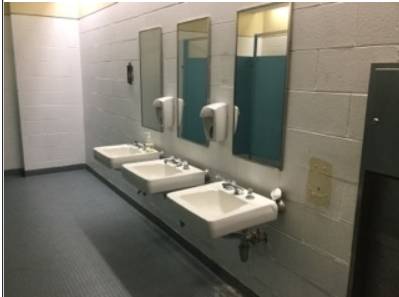
Plumbing underneath is exposed Dispensers not within reach range Audible and visible alarms not provided	- 49"	Insulate or otherwise configure pipes to prevent contact, for at least one lavatory. Relocate soap dispenser to 42" max. above the floor. When fire system is updated, ensure that a visible and audible fire alarm is installed.	1
50	Single-User Toilet Room	1		Lavatory	N/A

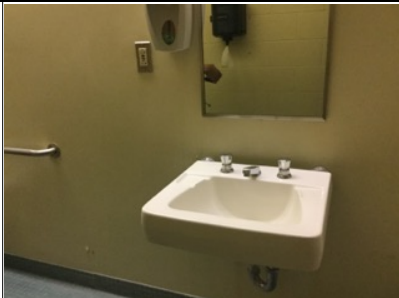
Dispensers not within reach range	55"	Relocate dispenser to 42" max. above the floor.	1
51	Women's Toilet Room	1		Lavatory

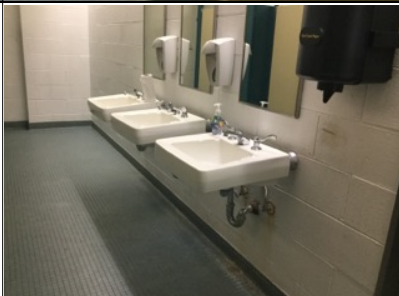
Dispensers not within reach range	43", 47"	Relocate dispenser to 42" max. above the floor.	1

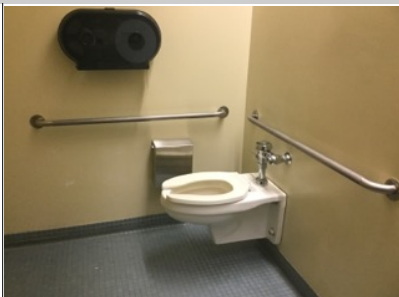
Single-User Toilet										
52	Single-User Toilet Room	1		Single-User Toilet	N/A

Flush control not on open side Side or rear grab bar < 33" or > 36" high Toilet paper dispenser is not compliant	30" - -	Relocate the flush control to the open side. Mount grab bars to 33"- 36" above the floor. Relocate toilet paper so that it is 15" min high, located under the grab bar, and between 7" and 9" from the front of the toilet. Replace dispenser if it does not allow continuous paper flow.	1

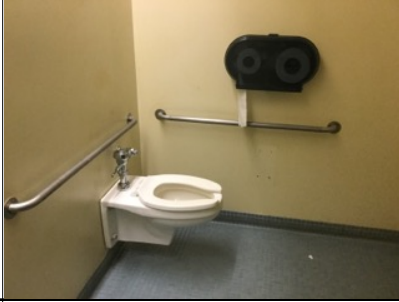
ID	Location	Floor	Room	Element	Type	Photo	Issues	Current Measure	Recommendations	Quantity
53	Single-User Toilet Room	2		Single-User Toilet	N/A

Side or rear grab bar < 33" or > 36" high Toilet paper dispenser is not compliant	29" -	Mount grab bars to 33"- 36" above the floor. Relocate toilet paper so that it is 15" min high, located under the grab bar, and between 7" and 9" from the front of the toilet. Replace dispenser if it does not allow continuous paper flow.	1
54	Single-User Toilet Room	2		Single-User Toilet	N/A

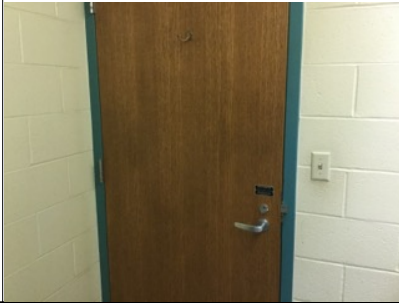
Hook located > 48" high	69"	Locate hook no higher than 48" above the finish floor.	1
Toilet Compartment										
55	Women's Toilet Room	1		Toilet Compartment	Accessible Compartment

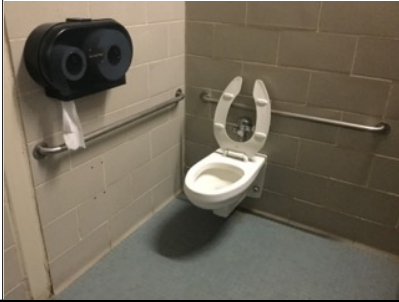
Door has malfunctioning self-closing hinge Side or rear grab bar < 33" or >36" high Flush control not on open side Non-compliant toilet paper dispenser Coat hook > 48"	- 30" - 70"	Repair hinge. Locate grab bars between 33"- 36" above the finish floor. Provide the flush control on the open side of the toilet (transfer side). Relocate toilet paper so that it is 15" min high, located under the grab bar, and between 7" and 9" from the front of the toilet. Replace dispenser if it does not allow continuous paper flow. Lower coat hook so that it is no higher than 48".	1

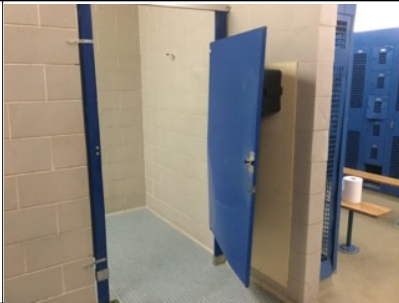
56	Men's Toilet Room	1		Toilet Compartment	Accessible Compartment

Door has malfunctioning self-closing hinge Coat hook > 48"	- 69"	Repair hinge. Lower coat hook so that it is no higher than 48".	1
57	Boy's Toilet Room	2		Toilet Compartment	Accessible Compartment

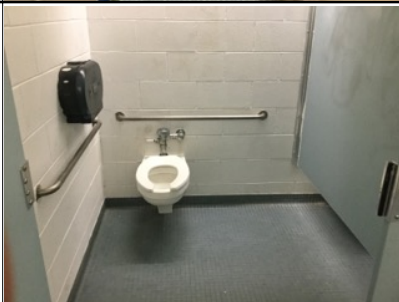
Side or rear grab bar < 33" or >36" high Flush control not on open side Non-compliant toilet paper dispenser Coat hook > 48"	30" - 66"	Locate grab bars between 33"- 36" above the finish floor. Provide the flush control on the open side of the toilet (transfer side). Relocate toilet paper so that it is 15" min high, located under the grab bar, and between 7" and 9" from the front of the toilet. Lower coat hook so that it is no higher than 48".	1

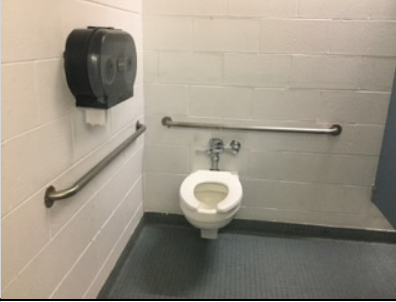
ID	Location	Floor	Room	Element	Type	Photo	Issues	Current Measure	Recommendations	Quantity
58	Men's Toilet Room	1		Toilet Compartment	Accessible Compartment

Side or rear grab bar < 33" or >36" high Flush control not on open side Non-compliant toilet paper dispenser	30" - -	Locate grab bars between 33"- 36" above the finish floor. Provide the flush control on the open side of the toilet (transfer side). Relocate toilet paper so that it is 15" min high, located under the grab bar, and between 7" and 9" from the front of the toilet. Replace dispenser if it does not allow continuous paper flow.	1
59	Music Room Men's Toilet Room	1		Toilet Compartment	Accessible Compartment

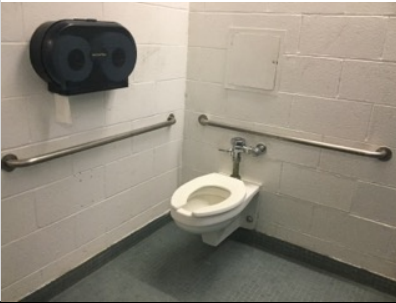
Side or rear grab bar < 33" or >36" high Flush control not on open side Non-compliant toilet paper dispenser	29" - -	Locate grab bars between 33"- 36" above the finish floor. Provide the flush control on the open side of the toilet (transfer side). Relocate toilet paper so that it is 15" min high, located under the grab bar, and between 7" and 9" from the front of the toilet. Replace dispenser if it does not allow continuous paper flow.	1

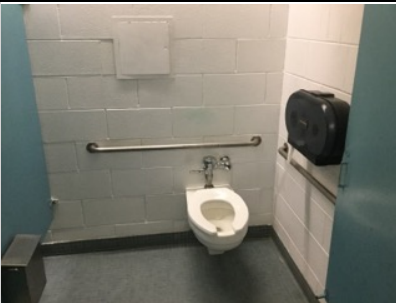
60	Girl's Toilet Room	2		Toilet Compartment	Accessible Compartment

Side or rear grab bar < 33" or >36" high Non-compliant toilet paper dispenser	30" -	Locate grab bars between 33"- 36" above the finish floor. Relocate toilet paper so that it is 15" min high, located under the grab bar, and between 7" and 9" from the front of the toilet. Replace dispenser if it does not allow continuous paper flow.	1
61	Men's Toilet Room	1		Toilet Compartment	Accessible Compartment

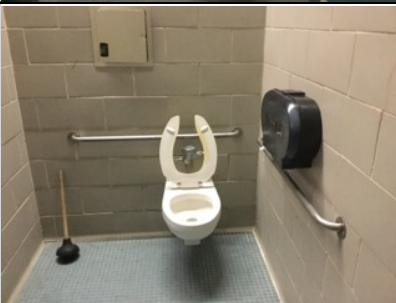
Side or rear grab bar < 33" or >36" high Non-compliant toilet paper dispenser	30" -	Locate grab bars between 33"- 36" above the finish floor. Relocate toilet paper so that it is 15" min high, located under the grab bar, and between 7" and 9" from the front of the toilet. Replace dispenser if it does not allow continuous paper flow.	1
62	Music Room Women's Toilet Room	1		Toilet Compartment	Accessible Compartment

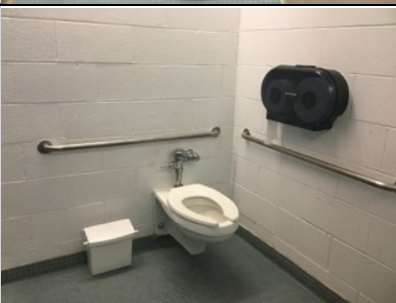
Side or rear grab bar < 33" or >36" high Non-compliant toilet paper dispenser Coat hook > 48"	31" - 57"	Locate grab bars between 33"- 36" above the finish floor. Relocate toilet paper so that it is 15" min high, located under the grab bar, and between 7" and 9" from the front of the toilet. Replace dispenser if it does not allow continuous paper flow. Lower coat hook so that it is no higher than 48".	1

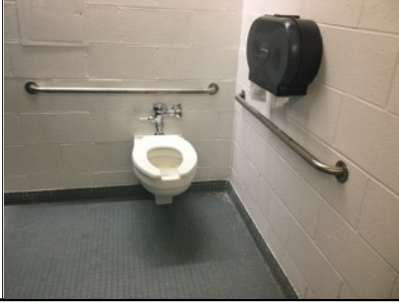
ID	Location	Floor	Room	Element	Type	Photo	Issues	Current Measure	Recommendations	Quantity
63	Women's Toilet Room	1		Toilet Compartment	Accessible Compartment

Side or rear grab bar < 33" or >36" high Non-compliant toilet paper dispenser Coat hook > 48"	31" - 53"	Locate grab bars between 33"- 36" above the finish floor. Relocate toilet paper so that it is 15" min high, located under the grab bar, and between 7" and 9" from the front of the toilet. Replace dispenser if it does not allow continuous paper flow. Lower coat hook so that it is no higher than 48".	1
Dispensers										
64	Women's and Men's Toilet Rooms, Single-User Toilet Room, Utility Sink	1		Dispensers	Paper Towel Dispenser

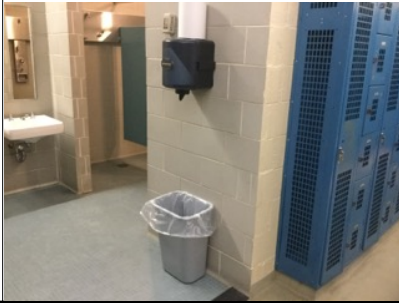
Controls > 42" high Dispenser acts as a protruding object	55" 11"	Relocate so the control of the paper towel dispenser is 42" max. above the finish floor and out of the path of travel.	5
Shower Compartment

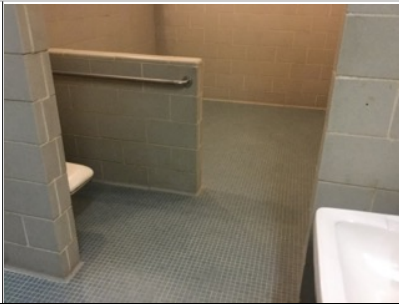
65	Men's Shower, Women's Shower	1		Shower Compartment	Transfer Type

Clear floor space not provided at shower	-	Provide a 48" x 36" clear floor space for a transfer shower that does not obstruct the path of travel to the other showers.	2
66	Men's Shower, Women's Shower	1		Shower Compartment	Transfer Type

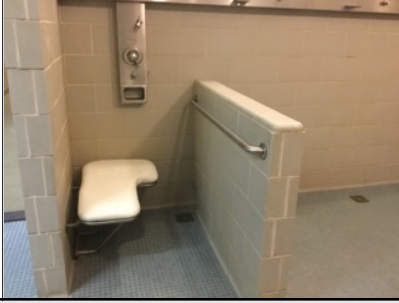
Grab bars not provided Control height < 38" or > 48" Controls not located on opposite seat (Transfer type)	- 49" -	Provide compliant side grab bar for transfer shower. Relocate controls at 48" max. above the finish floor. Relocate controls on the wall opposite the seat.	2
Additional Access

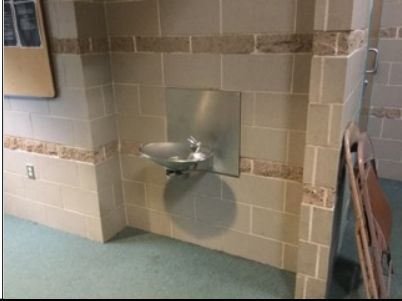
ID	Location	Floor	Room	Element	Type	Photo	Issues	Current Measure	Recommendations	Quantity
Drinking Fountains										
67	Gymnasium, Outside First Floor Toilet Rooms, Outside Music Room Toilet Rooms, Second Floor Hallway	1, 2		Drinking Fountains	Low

No drinking fountain provided for standing users	-	Provide an additional drinking fountain for standing users or install a Hi-Lo drinking fountain.	4
Sink										
68	Utility Sink	1		Sink	Other

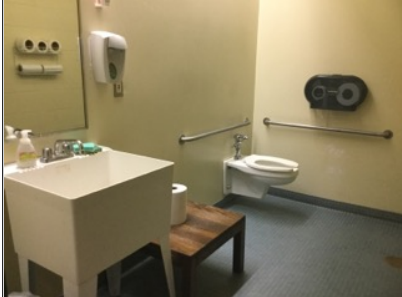
Toe and knee clearances not provided Dispenser not within reach range	20"h 54"	Ensure there is a 27" knee clearance positioned for a forward approach. Relocate dispenser 48" max. above the finish floor or ground.	1
