## Brooks Park Harwich, MA

## Town of Harwich ADA Transition Plan

July 2018

### Brooks Park, Harwich, MA Renovation 2017 (Ongoing)

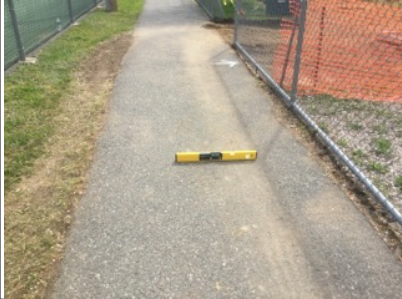
ID	Location	Floor	Room	Element	Type	Photo	Issues	Current Measure	Recommendations	Quantity
<b>Approach and Entrance</b>										
<b>Exterior Access Route</b>										
1	Route by Playground Towards Courts	Ext.		Exterior Access Route	Walkway

Cross slope > 1:48 (2.08%)	4.2%	Reduce cross slope to be no steeper than 1:48 (2.08%).	1
2	Entrance to Tennis Court - East Side	Ext.		Exterior Access Route	Walkway

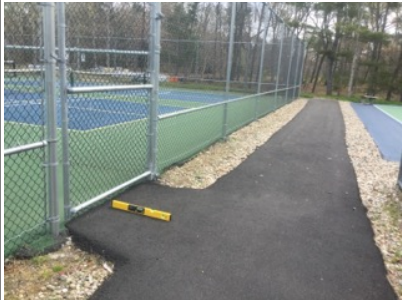
Running slope > 1:20 (5.00%)	8.1%	Reduce the running slope to be no steeper than 1:20 (5.00%).	1
3	Entrance to Gazebo Area	Ext.		Exterior Access Route	Exterior

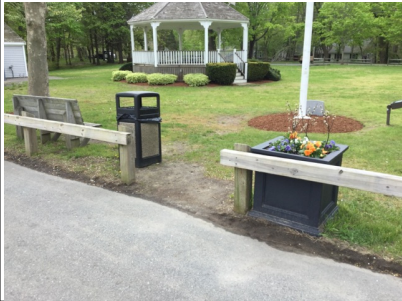
Accessible route not provided	-	Ensure an accessible route is provided to the gazebo. (Cost estimate for a 30 ft. long stone dust path.)	1
4	Gazebo	Ext.		Exterior Access Route	N/A

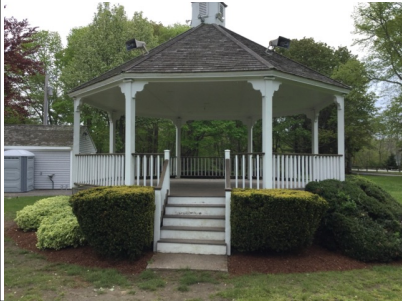
Accessible route not provided	-	Providing an accessible route to this area might be technically infeasible. Consider relocating the program as needed.	1

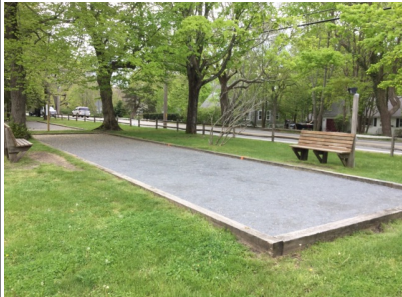
5	Petanque Court	Ext.		Exterior Access Route	Exterior

Accessible route not provided	-	Ensure an accessible route is provided to the petanque. (Cost estimate for a 15 ft. long stone dust path.)	1

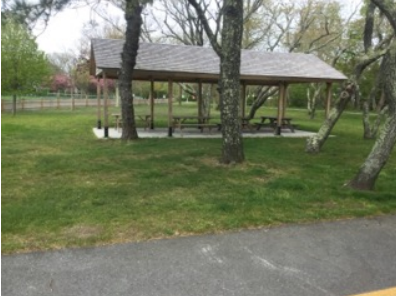
ID	Location	Floor	Room	Element	Type	Photo	Issues	Current Measure	Recommendations	Quantity
6	Pavilion	Ext.		Exterior Access Route	Exterior

Accessible route not provided	-	Ensure an accessible route is provided.	1
7	Picnic Area Near Baseball Field	Ext.		Exterior Access Route

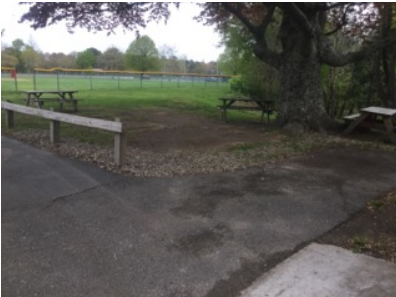
Accessible route not provided	-	Ensure an accessible route is provided.	1
8	Seating Area on Main St.	Ext.		Exterior Access Route

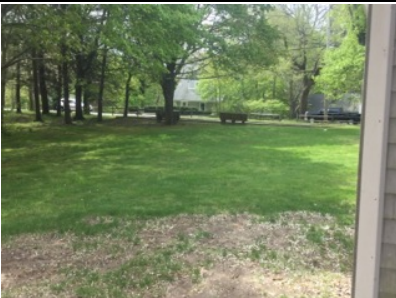
Accessible route not provided	-	Ensure an accessible route is provided.	1
<b>Off-Street Parking Lot or Garage</b>										
9	Northern Parking Lot	Ext.		Off-Street Parking Lot or Garage

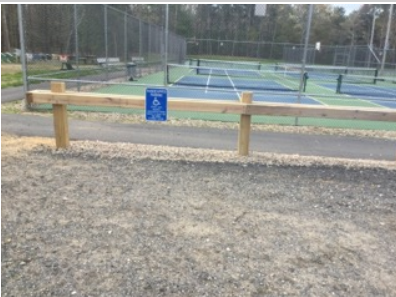
Total # of parking Total # of designated accessible parking spaces Total # of designated van accessible spaces Sign > 96" above finished grade (MAAB)	50 2 0 19"	Provide a marked car and a marked van accessible space and access aisle. Locate sign including sign with the words "Van Accessible" at the van accessible space 60" min. and 96" max. above the ground.	2

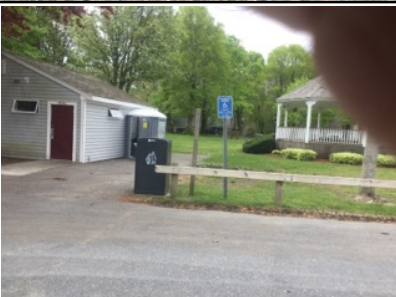
10	Southern Parking Lot	Ext.		Off-Street Parking Lot or Garage

Total # of parking Total # of designated accessible parking spaces Total # of designated van accessible spaces Access aisle not provided Sign does not have the designation "Van Accessible"	20 1 - - -	Provide a marked van accessible space and access aisle (stripe) with a sign that includes the words "Van Accessible" positioned 60" min. and 96" max. above the ground.	1

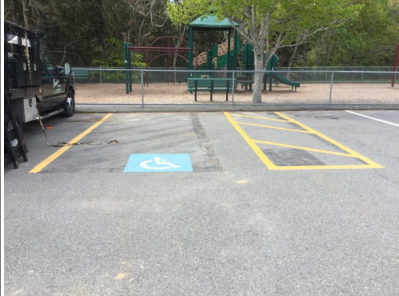
ID	Location	Floor	Room	Element	Type	Photo	Issues	Current Measure	Recommendations	Quantity
11	Parking Lot - Near Playground	Ext.		Off-Street Parking Lot or Garage	Visitor

Sign not provided	-	Provide a sign with the bottom of the sign 60" min. above the ground and the top 96" max. above the ground.	1
12	Parking Lot - Near Tennis Court	Ext.		Off-Street Parking Lot or Garage	Visitor

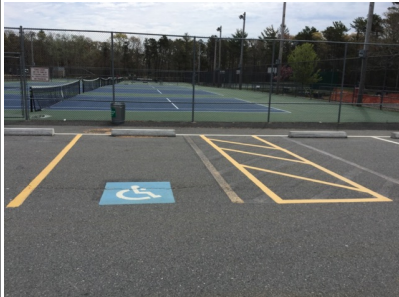
Sign not provided	-	Provide a sign with the bottom of the sign 60" min. above the ground and the top 96" max. above the ground. Add the designation "Van Accessible" to the sign.	1
<b>Entrance</b>										
13	Men's Toilet Room Entrance	Ext.		Entrance	Other

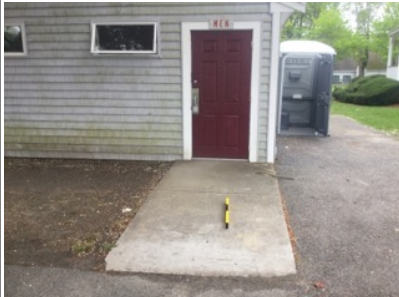
Running slope > 1:20 (5.00%) Door requires >15 lbs. of force to open (MAAB)	6.8% 19 lbs.	Reduce the running slope to be no steeper than 1:20 (5.00%). Adjust closers so doors do not require more than 15 pounds of force.	1
14	Women's Toilet Room Entrance	Ext.		Entrance

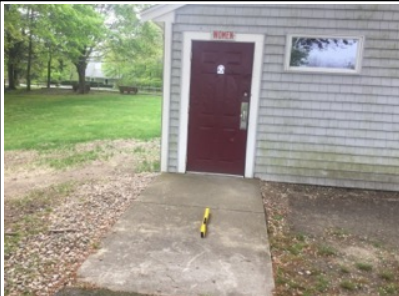
Running slope > 1:20 (5.00%) Door requires >15 lbs. of force to open (MAAB)	6.4% 19 lbs	Reduce the running slope to be no steeper than 1:20 (5.00%). Adjust closers so doors do not require more than 15 pounds of force.	1

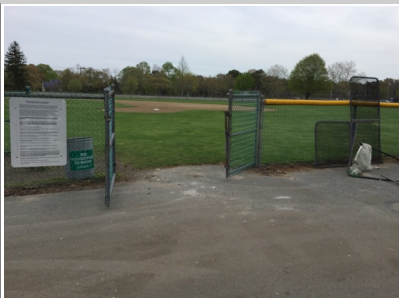
<b>Access to Goods and Services</b>										
<b>Doors, Doorways, &amp; Gates</b>										
15	Baseball	Ext.		Doors, Doorways, & Gates	Other

Maneuvering clearance(s) not provided 10" solid surface not provided	- -	Provide a 48" min. maneuvering clearance at at the gate. Swinging door and gate surfaces within 10 inches of the finish floor or ground measured vertically shall have a smooth surface on the push side extending the full width of the gate.	1

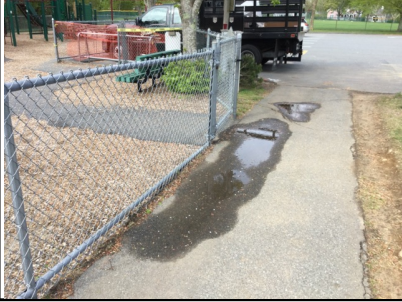
ID	Location	Floor	Room	Element	Type	Photo	Issues	Current Measure	Recommendations	Quantity
16	Entrance to Playground	Ext.		Doors, Doorways, & Gates	N/A

10" solid surface not provided	-	Swinging door and gate surfaces within 10 inches of the finish floor or ground measured vertically shall have a smooth surface on the push side extending the full width of the door or gate.	1
<b>Signage</b>										
17	Men's Toilet Room Entrance	Ext.		Signage	Designation	 	Raised characters not provided Visual characters < 40" above ground Sign not located on the latch side of the door	- 80" -	Provide text with raised characters duplicated in braille. Include the International Symbol of Accessibility. Mount visual sign so that the baseline of the lowest character is 40" min. and 60" max. above finish floor located on the latch side.	1
18	Women's Toilet Room Entrance	Ext.		Signage		 	Raised characters not provided Visual characters < 40" above ground Sign not located on the latch side of the door	- 80" -	Provide text with raised characters duplicated in braille. Include the International Symbol of Accessibility. Mount visual sign so that the baseline of the lowest character is 40" min. and 60" max. above finish floor located on the latch side.	1

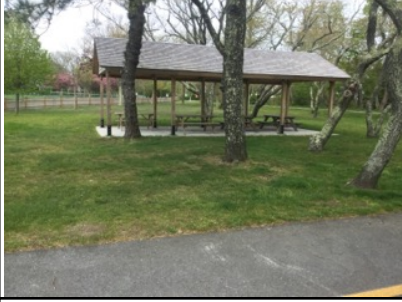
<b>Picnic Tables</b>										
19	Pavilion	Ext.		Picnic Tables	2

Number of seating spaces at picnic tables Number of accessible seating spaces Toe or knee clearance at table not provided	4 - - -	Provide at least one picnic table with toe and knee clearance.	1
20	Near Playground	Ext.		Picnic Tables	N/A

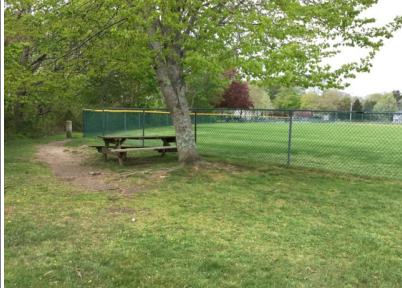
Toe or knee clearance at table not provided Picnic table not on an accessible route	- -	Provide at least one picnic table with toe and knee clearance. Locate picnic table on an accessible route.	1

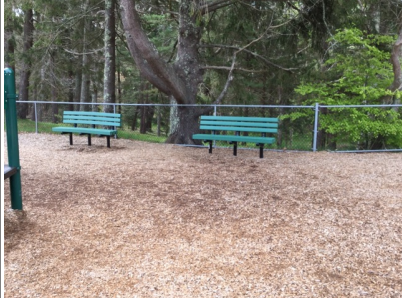
ID	Location	Floor	Room	Element	Type	Photo	Issues	Current Measure	Recommendations	Quantity
<b>Benches</b>										
21	Playground	Ext.		Benches	N/A

No accessible route to 20% of benches	-	Provide an accessible route to at least one bench in this area. (Cost estimate for a 30 ft. long asphalt route.)	1
22	Gazebo Area	Ext.		Benches	N/A

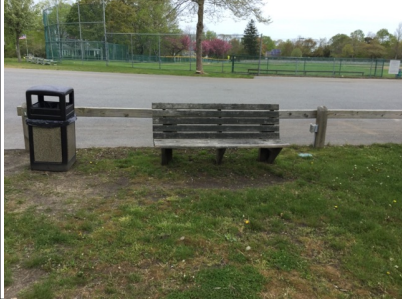
No accessible route to 20% of benches	-	Provide an accessible route to the bench. Ensure that a clear floor space of 36" wide min. by 48" deep min. adjacent to the bench provides shoulder alignment. The shoulder alignment of the wheelchair space shall be measured 36" from the front of the wheelchair space. (Cost estimate for a 6 ft. long stone dust path.)	1
<b>Toilet &amp; Bathing Rooms</b>										
<b>Overall Access</b>										
23	Men's Toilet Room	Ext.		Overall Access

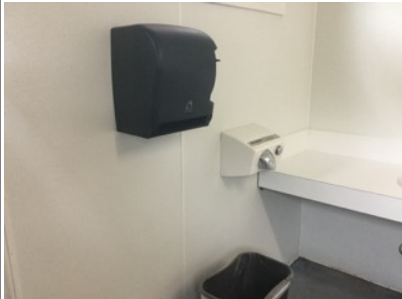
Dispensers not within reach range Audible and visible alarms not provided	45" -	Lower dispensers to 42" max. above the floor. When fire system is updated, ensure that a visible and audible fire alarm is installed. Provide a cane detectible barrier 27" max. above the floor below dispenser.	1

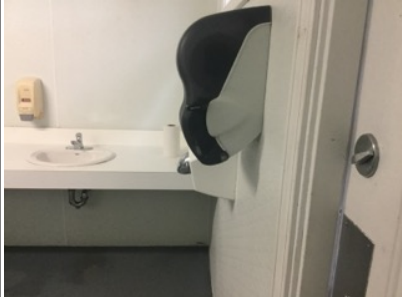
24	Women's Toilet Room	Ext.		Overall Access

Dispensers not within reach range Audible and visible alarms not provided	45" -	Lower dispensers to 42" max. above the floor. When fire system is updated, ensure that a visible and audible fire alarm is installed. Provide a cane detectible barrier 27" max. above the floor below dispenser.	1

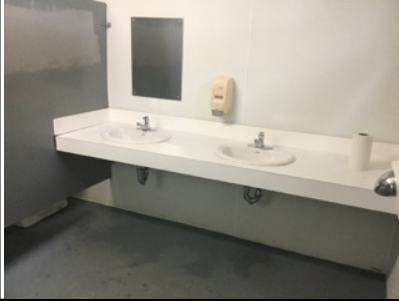
ID	Location	Floor	Room	Element	Type	Photo	Issues	Current Measure	Recommendations	Quantity
<b>Lavatory</b>										
25	Women's Toilet Room	Ext.		Lavatory

Exposed plumbing underneath	-	Insulate or otherwise configure pipes to prevent contact, for at least one lavatory.	1
26	Men's Toilet Room	Ext.		Lavatory

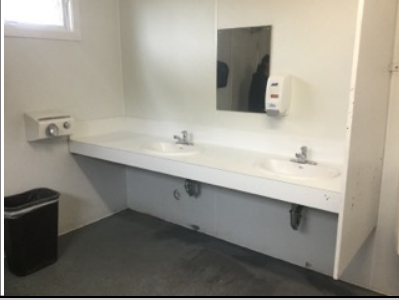
Exposed plumbing underneath Mirror above lavatory w/reflective surface > 40"	- 43"	Insulate or otherwise configure pipes to prevent contact, for at least one lavatory. Lower mirror so that the bottom surface is at 40" max. above finish floor.	1
<b>Toilet Compartment</b>										
27	Men's Accessible Toilet	Ext.		Toilet Compartment

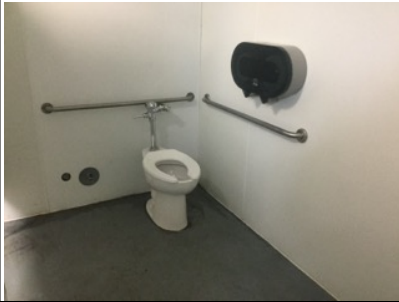
Door with malfunctioning self-closing hinge Side or rear grab bar < 33" or > 36" high Toilet paper dispenser mounted over grab bar (MAAB)	- 31" -	Repair hinge.  Locate grab bars between 33"- 36" above the finish floor.  Relocate toilet paper so that it is between 15" and 48" above the finish floor and between 7" and 9" from the front of the toilet.	1

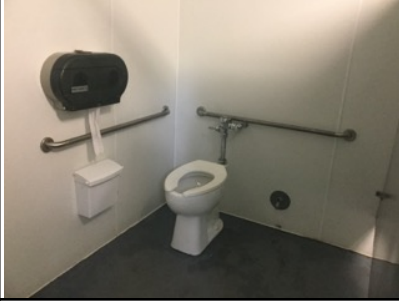
28	Women's Accessible Toilet	Ext.		Toilet Compartment

Side or rear grab bar < 33" or > 36" high Flush control not on open side Non-compliant toilet paper dispenser Coat hook > 48" Rear grab bar < 24" from toilet centerline	31.5" 19" - -	Locate grab bars between 33"- 36" above the finish floor and 24" from the centerline of the toilet.  Provide the flush control on the open side of the toilet (transfer side).  Relocate toilet paper so that it is between 15" and 48" above the finish floor and between 7"	1
29	Men's Accessible Toilet	Ext.		Toilet Compartment

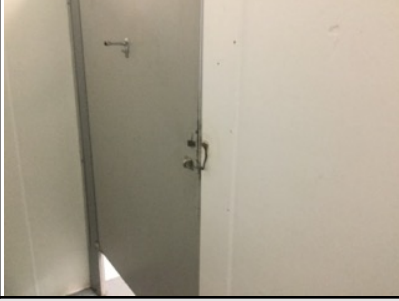
Coat hook > 48"	54"	Lower coat hook so that it is no higher than 48".	1
<b>Play and Sport Areas</b>

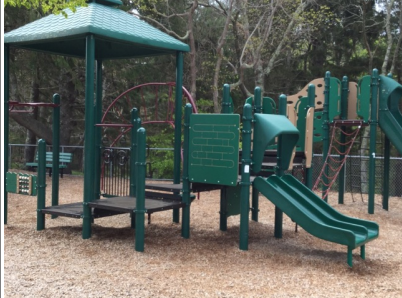
ID	Location	Floor	Room	Element	Type	Photo	Issues	Current Measure	Recommendations	Quantity
<b>Play Areas</b>										
30	Playground	Ext.		Play Areas	N/A

Accessible route not provided to ground level play components Surface not stable, firm, and slip-resistant	- -	Ensure an accessible route is provided to one of each type of ground level play component. Ensure an accessible route connect all ground level play components. Repair surface. <i>Note: Engineered wood chips are allowed but must be maintained regularly to ensure continued compliance with the ASTM F 1951 Standards.</i>	1
<b>Field</b>										
31	Baseball Field	Ext.		Field	Baseball

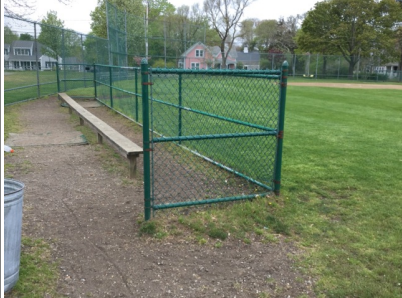
Not connected to an accessible-route	-	Ensure an accessible route is provided to team seating areas. (Cost estimate for a 30 ft. long stone dust path.)	1
<b>Court</b>										
32	Handball Court	Ext.		Court

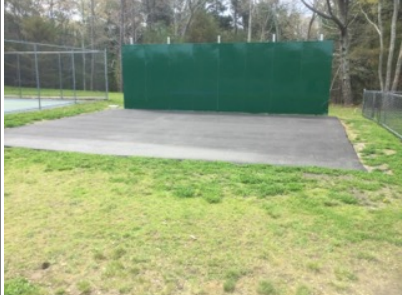
Not connected to accessible route	-	Ensure that court is connected to an accessible route.	1
