Town of Harwich ADA Transition Plan

June 2018

Chamber of Commerce

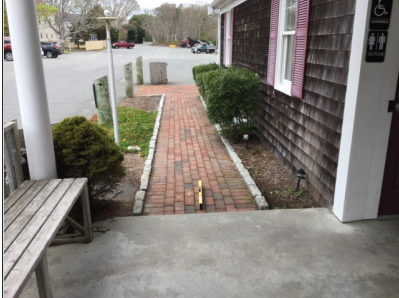
ID	Location	Floor	Room	Element	Type	Photo	Issues	Current Measure	Recommendations	Quantity
Approach and Entrance										
Exterior Access Route										
1	Near Toilet Rooms	Ext.		Exterior Access Route	Walkway

Level changes > 1/4"	0.5"	Alter change in level to be 1/4" high max. (cost for a 3' x 3' brick paver)	1
Off-Street Parking Lot or Garage										
2	Parking Lot (North Side)	Ext.		Off-Street Parking Lot or Garage	Visitor

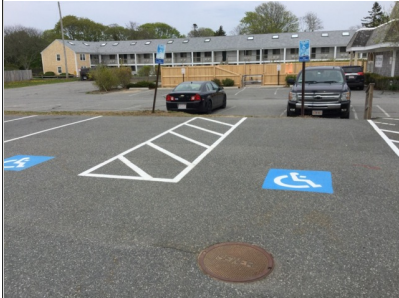
Vehicle space < 132" wide at van space Access aisle < 96" wide at van space	125" 56"	Provide a van accessible space that is at least 132" wide. Provide a marked access aisle that is at least 96" wide.	1
3	Parking Lot (West Side)	Ext.		Off-Street Parking Lot or Garage	Visitor

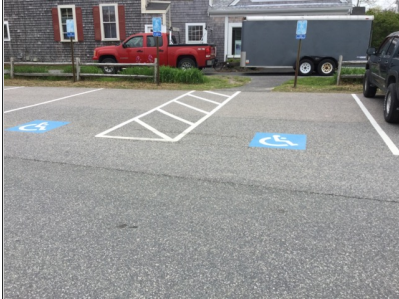
Vehicle space < 132" wide at van space Access aisle < 96" wide at van space	129.5" 53"	Provide a van accessible space that is at least 132" wide. Provide a marked access aisle that is at least 96" wide.	1

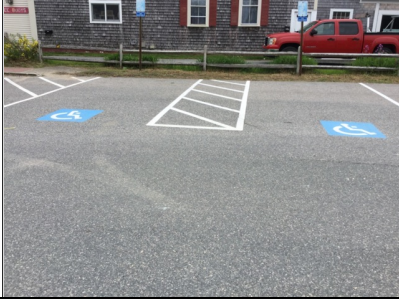
4	Parking Lot (West Side)	Ext.		Off-Street Parking Lot or Garage	Visitor

Vehicle space < 132" wide at van space Access aisle < 96" wide at van space	128" 56"	Provide a van accessible space that is at least 132" wide. Provide a marked access aisle that is at least 96" wide.	1
Access to Goods and Services

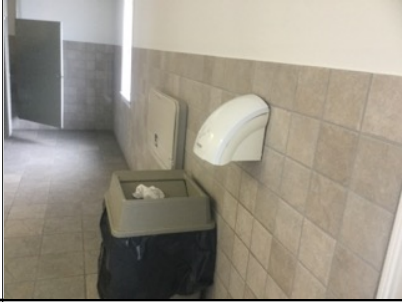
Obstructed by protruding objects	45"	Relocate hand dryer so it does not protrude into the circulation path.	1
6	Women's Toilet Room			Interior Access Route

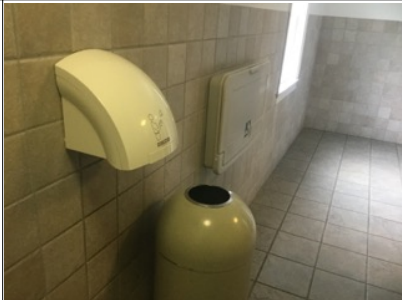
Obstructed by protruding objects	9"	Relocate hand dryer so it does not protrude into the circulation path.	1
Doors, Doorways, & Gates										
7	Egress Exit to Street			Doors, Doorways, & Gates	Emergency Egress

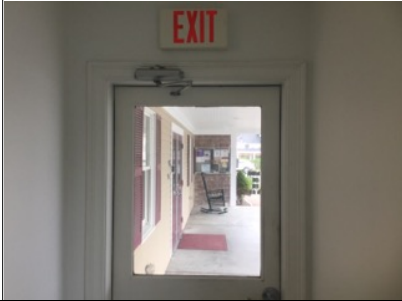
Maneuvering clearance(s) not provided	5.5"	Provide an automatic door opener.	1
8	Men's Toilet Room			Doors, Doorways, & Gates	Toilet Room

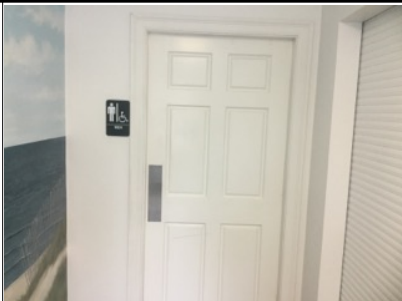
Door requires > 5 lbs. of force to open	15 lbs.	Adjust closers so doors do not require more than 5 pounds of force to open.	1
9	Women's Toilet Room			Doors, Doorways, & Gates	Toilet Room

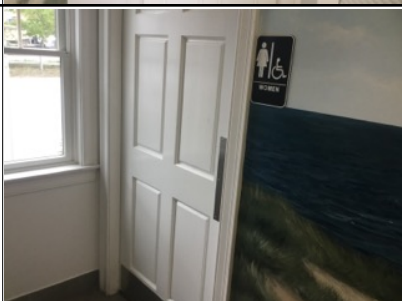
Door requires > 5 lbs. of force to open	20 lbs.	Adjust closers so doors do not require more than 5 pounds of force to open.	1

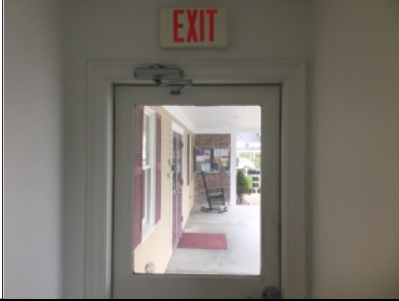
Braille not provided	-	Provide sign with raised characters and braille mounted on the latch side of the door.	1
Benches										
11	Main Entrance	Ext.		Benches	N/A

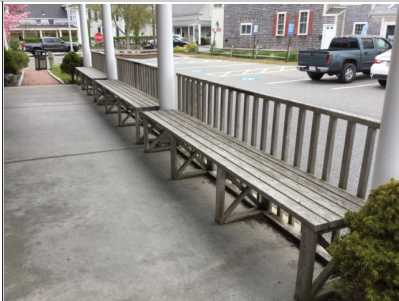
20% of benches have clear space < 36" x 48" Shoulder alignment not provided at bench	- -	Provide a 36" wide min. by 48" deep min. clear floor space next to at least one bench. Provide shoulder alignment with the adjacent wheelchair space. The shoulder alignment of the wheelchair space shall be measured 36" from the front of the wheelchair space.	1
Toilet & Bathing Rooms										
Overall Access										
12	Men's Toilet Room			Overall Access	Toilet Room

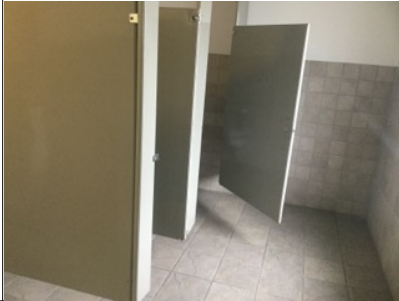
Audible and visible alarms not provided	-	When fire system is updated, ensure that a visible and audible fire alarm is installed.	1

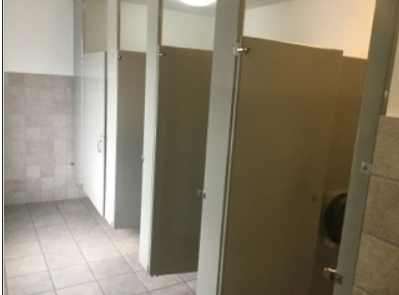
13	Women's Toilet Room			Overall Access	Toilet Room

Audible and visible alarms not provided	-	When fire system is updated, ensure that a visible and audible fire alarm is installed.	1

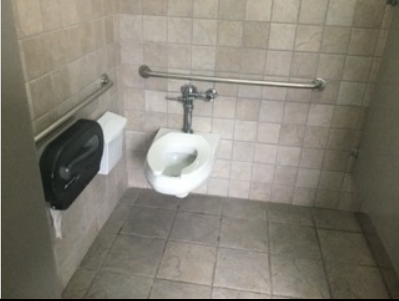
Toilet seat <17" or > 19" high	21"	Install a toilet with a seat height 17"- 19" above the floor.	1
15	Men's Accessible Toilet Room			Toilet Compartment	Accessible Compartment

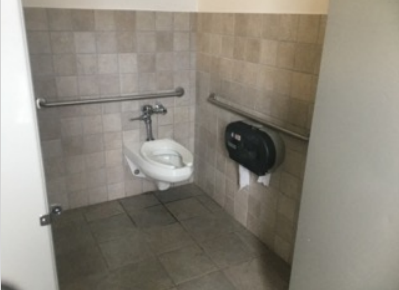
Toilet seat <17" or > 19" high Door has malfunctioning self-closing hinge	- 21"	Repair hinge. Install a toilet with a seat height 17"- 19" above the floor.	1
